SALT SPRINGS CHURCH ROAD SLOPE REHABILITATION OPTIONS

SITE CHARACTERIZATION AND ALTERNATIVE
ASSESSMENT PRESENTATION

County of Brant, Ontario

January 2025

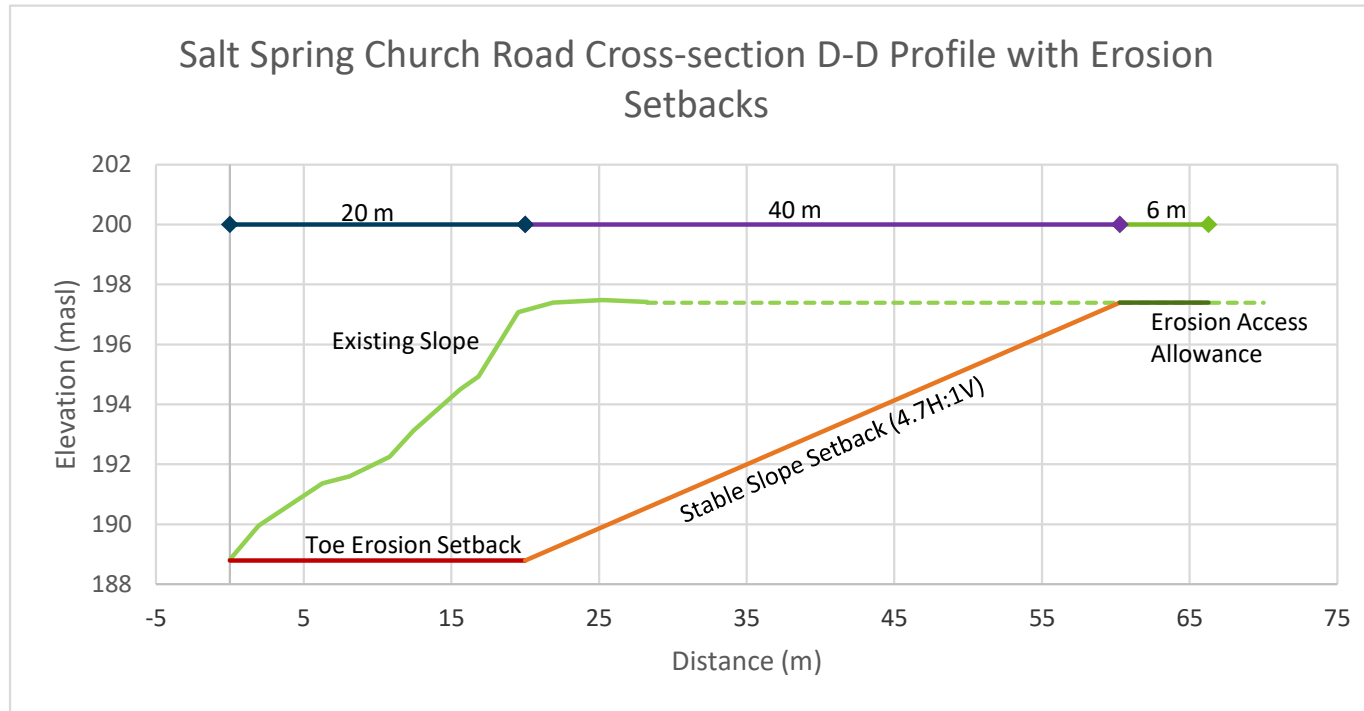
- The recommended average bank erosion rate determined for the site, based on historic aerial photo review, was determined to be 0.22 m/year, which serves as the basis of the toe erosion allowance of 22 m.
- Combined with the assessed geotechnical stable slope inclination of 4.7H to 1V (Pinchin 2023) and erosion access allowance of 6m as per MNR guidelines, the resulting erosion set back was determined.

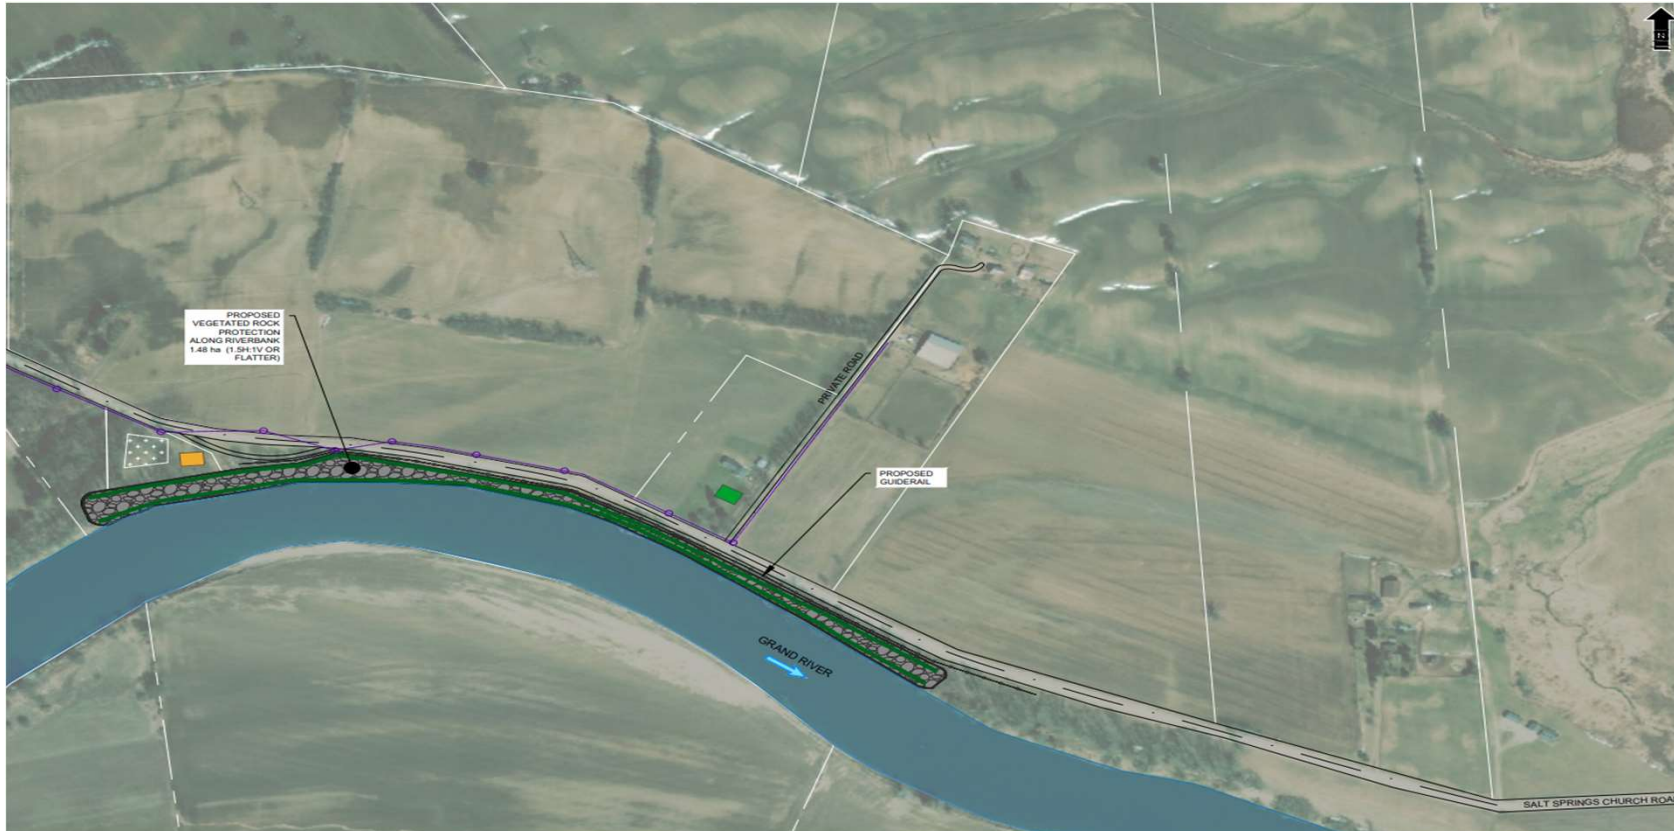
2- ALTERNATIVE 4: RETAIN AND PROTECT ROAD

- Repairing and protecting the existing alignment of Salt Springs Church Road.
- Implementing slope stabilization and erosion protection measures along the slope and riverbank.
- Installation of rock protection, slope regrading, surface water and groundwater drainage improvements.
- Regrading the slope to a flatter inclination will increase the stability of the slope.
