**PARSONS**

# Project File Report

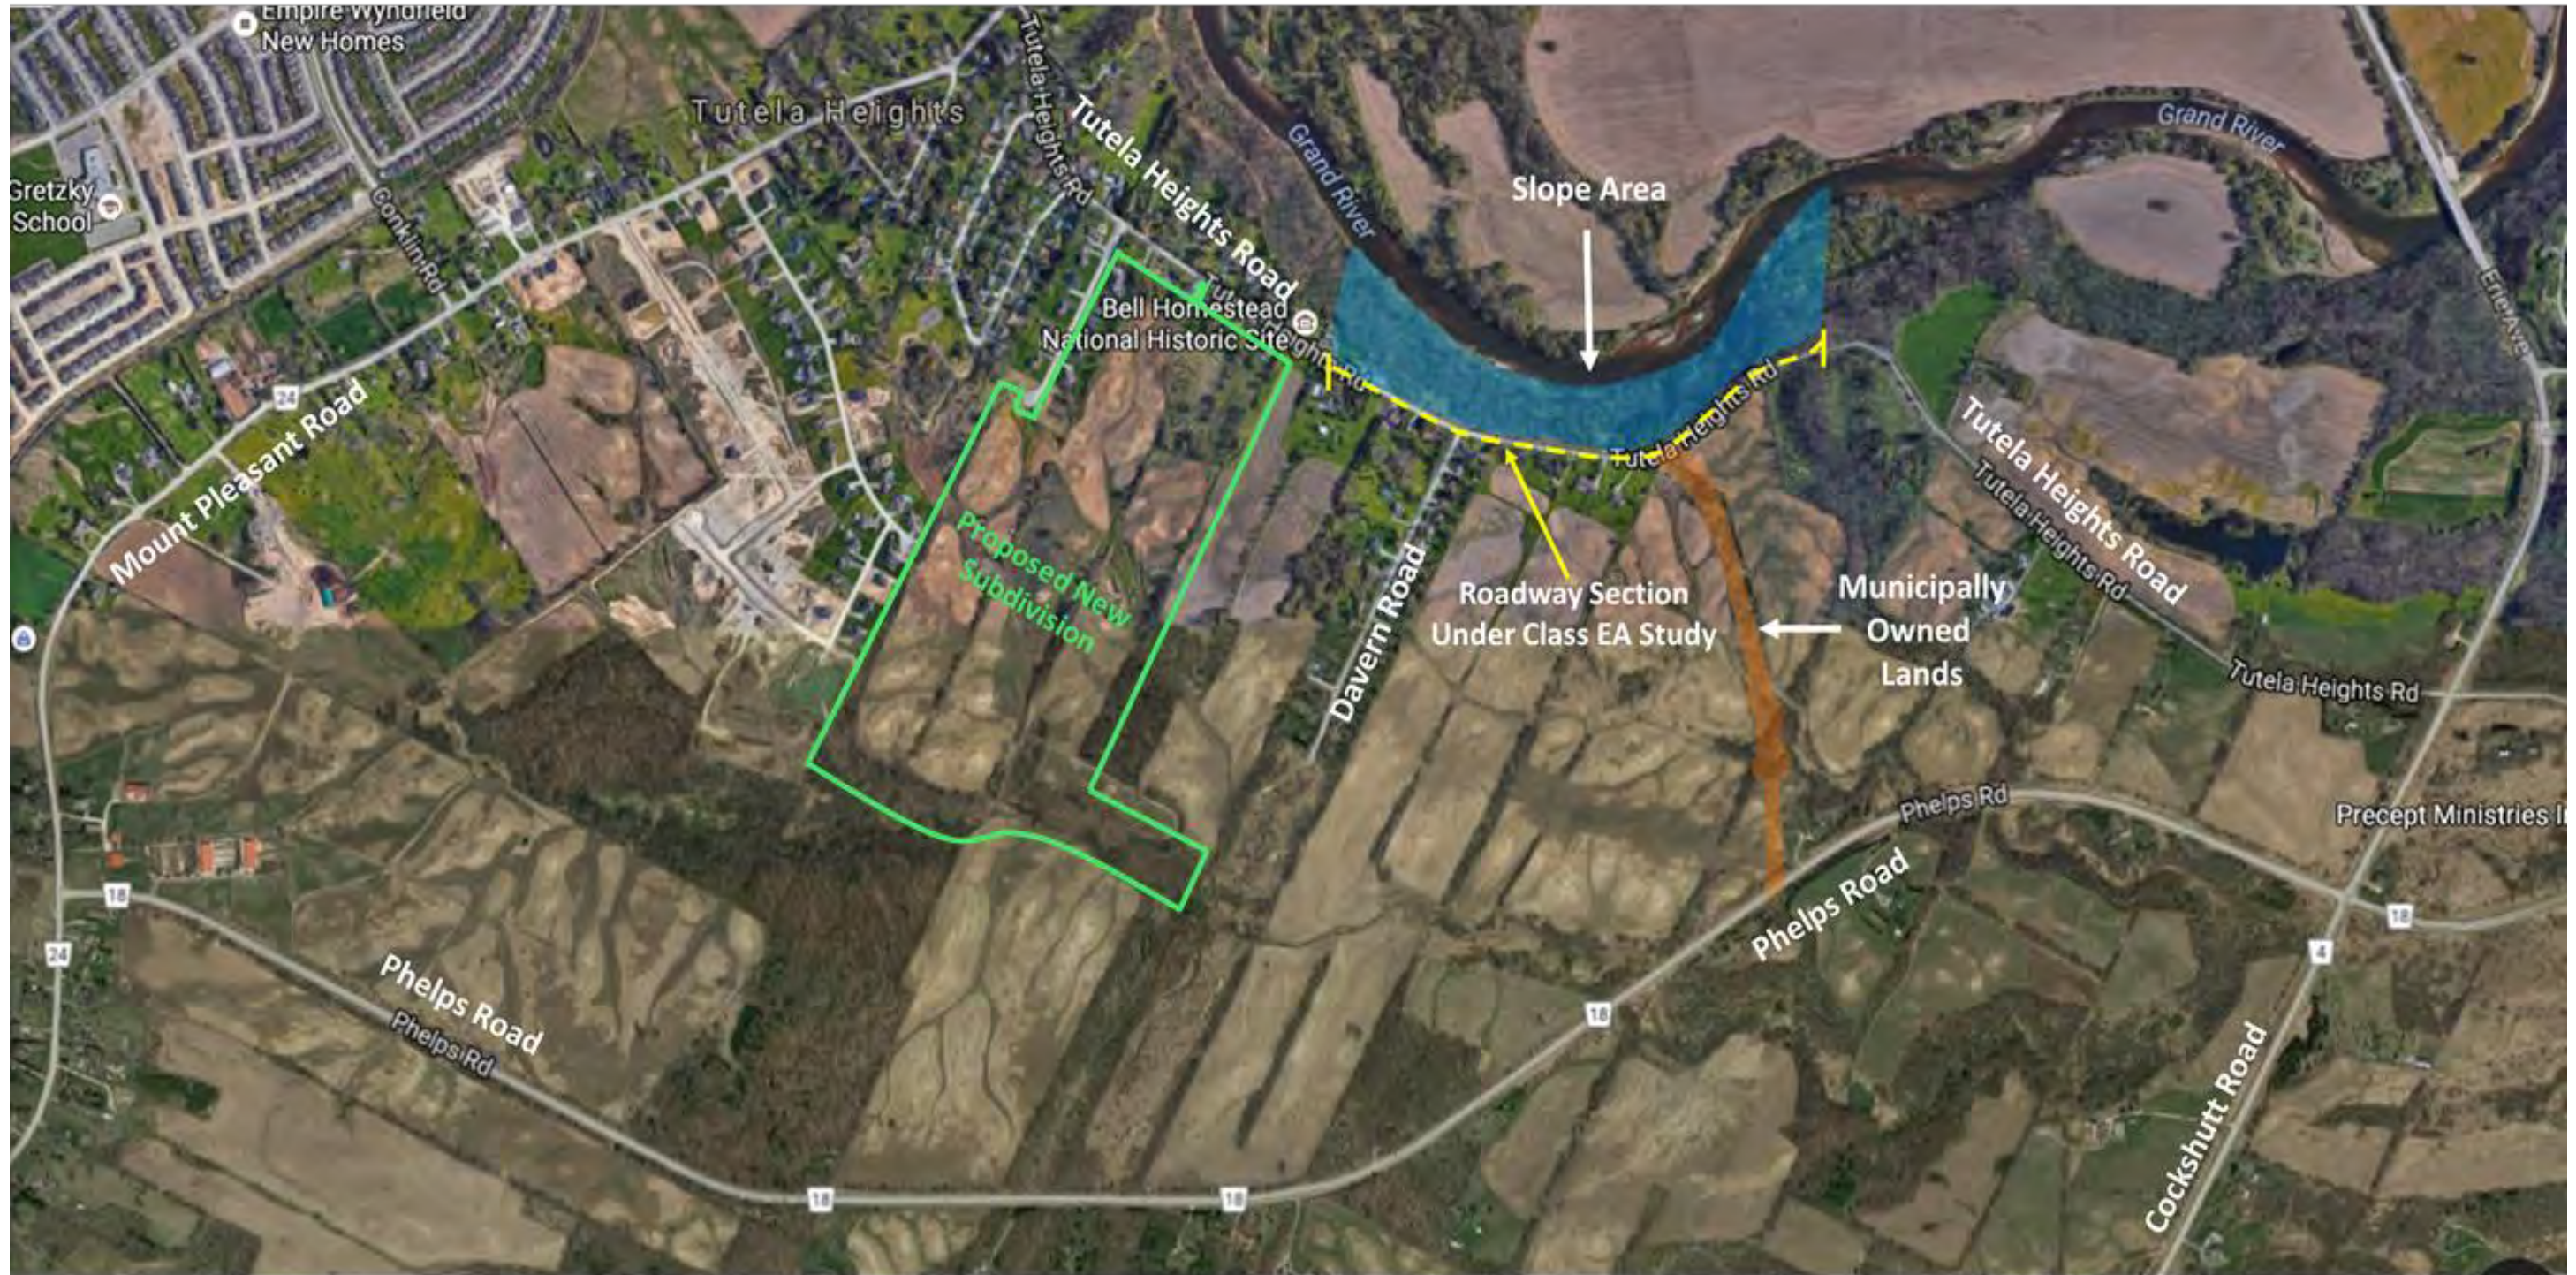
Figure 1.0 Key Plan of Study Area

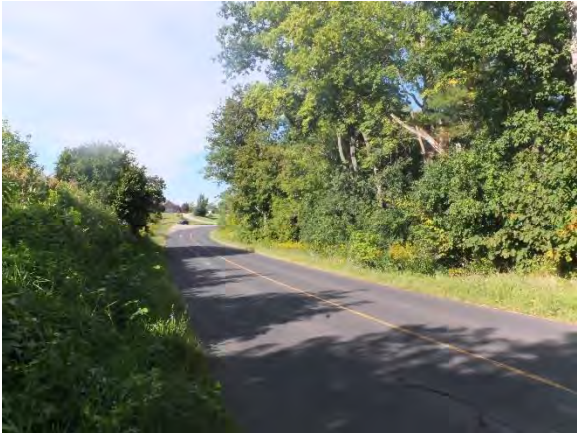
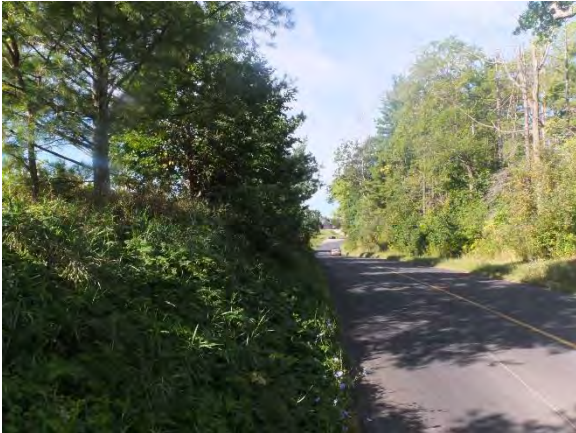
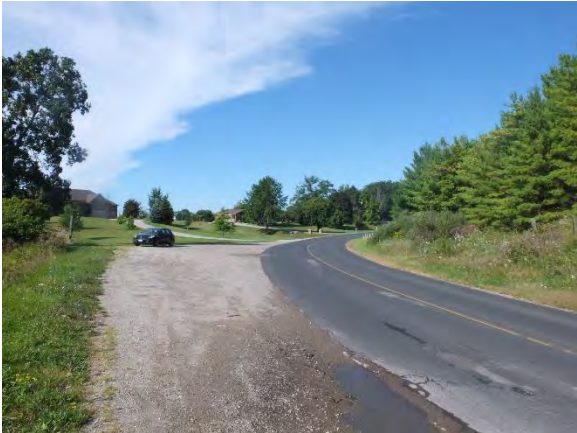
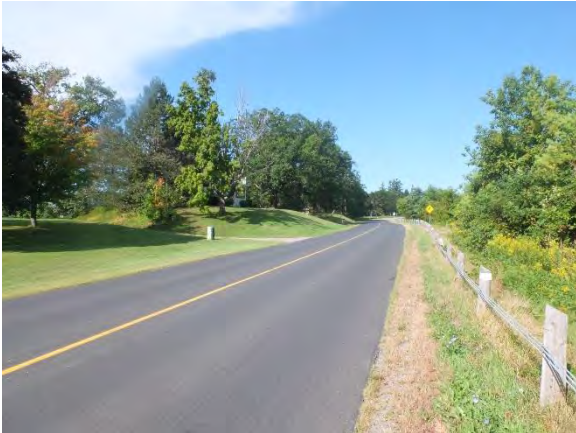
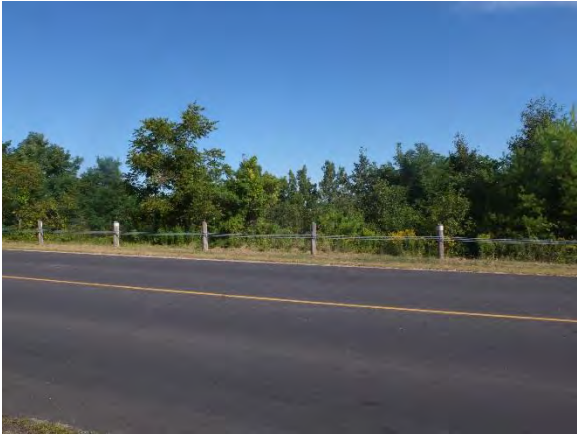
Cultural Meadow/Cultural Thicket/Cultural Woodland

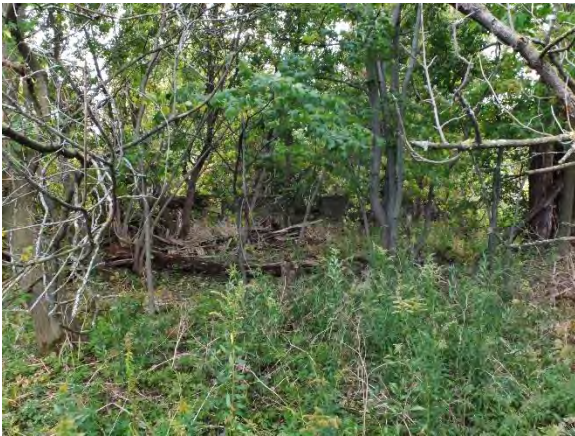
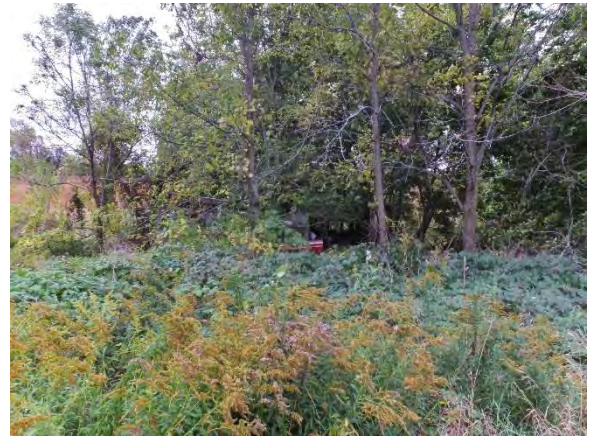
**Left:** Foundation of structure, possibly a house or barn; **Right:** Overgrown but still standing wooden structure

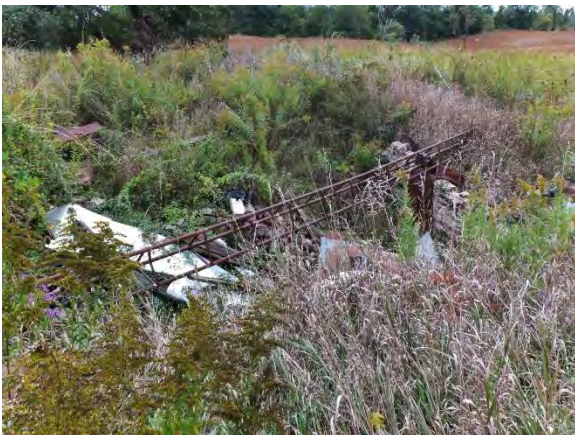
**Above:** Remains of another structure, possibly a silo.

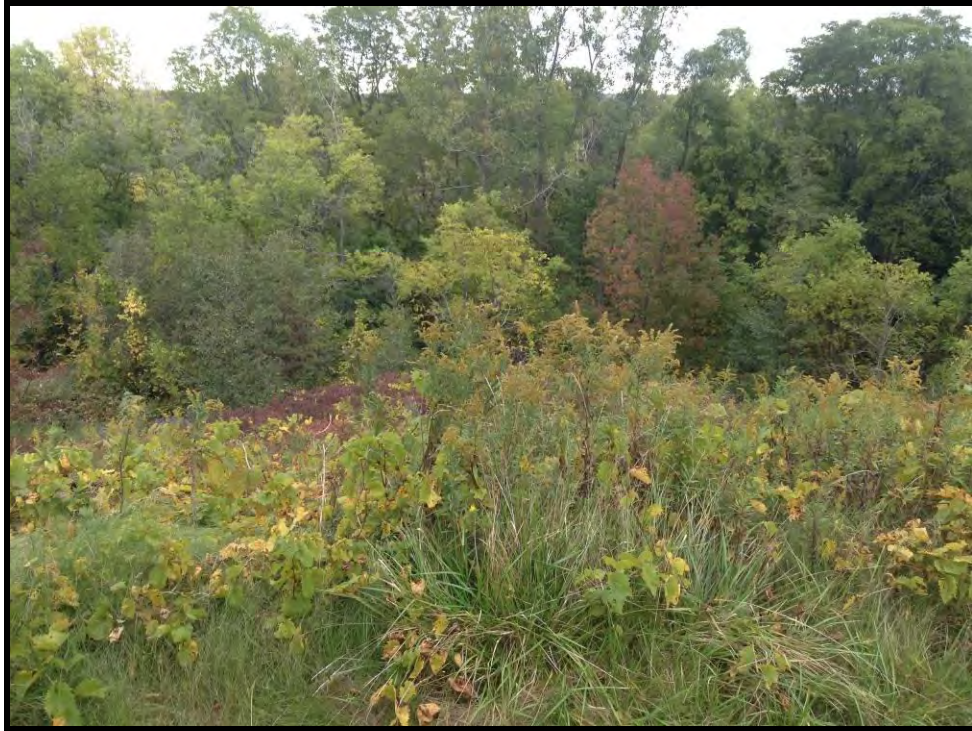
**Image 9: Field Conditions**  
(Photo Taken on October 2, 2015; Facing North)

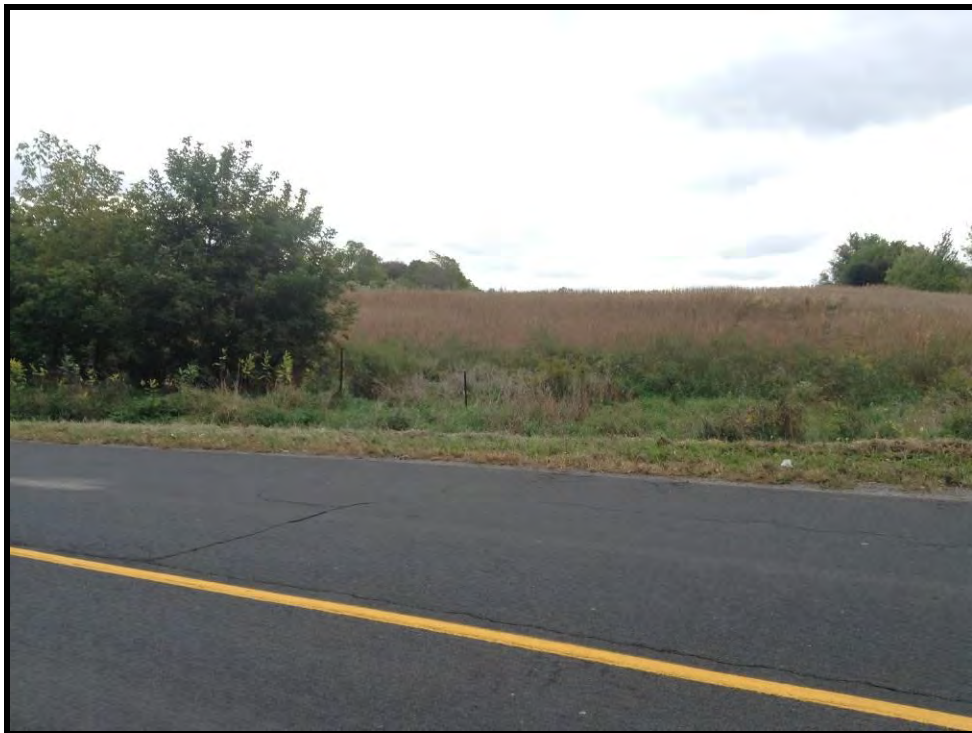
**Image 10: Field Conditions**  
(Photo Taken on October 2, 2015; Facing Southeast)

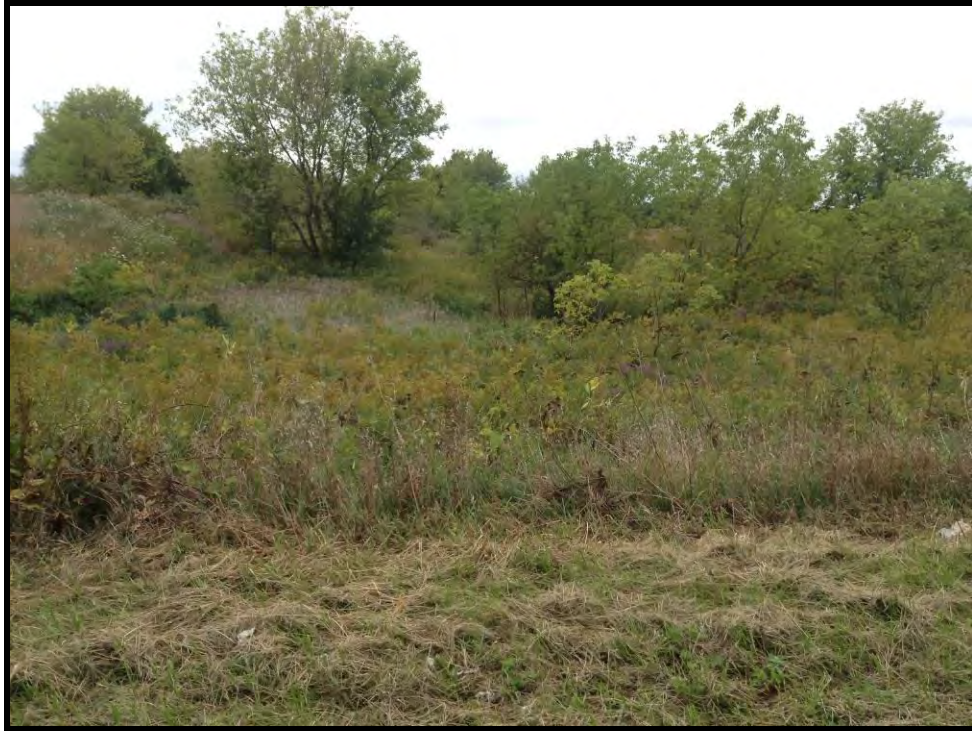
**Image 11: Field Conditions**  
(Photo Taken on October 2, 2015; Facing South)

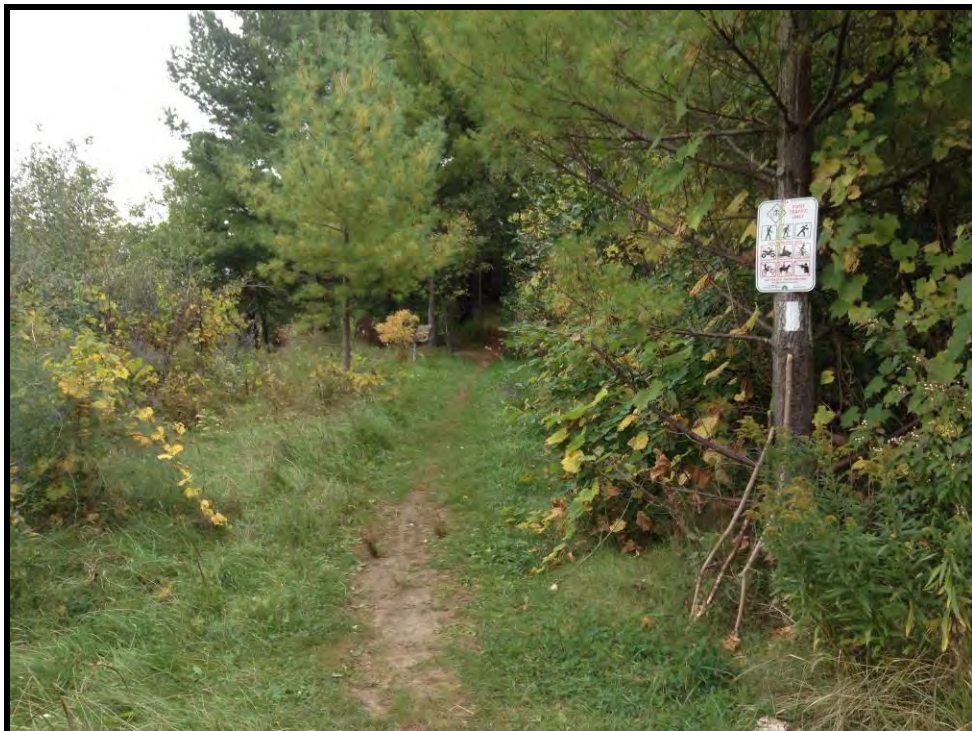
**Image 12: Field Conditions**  
(Photo Taken on October 2, 2015; Facing Northeast)

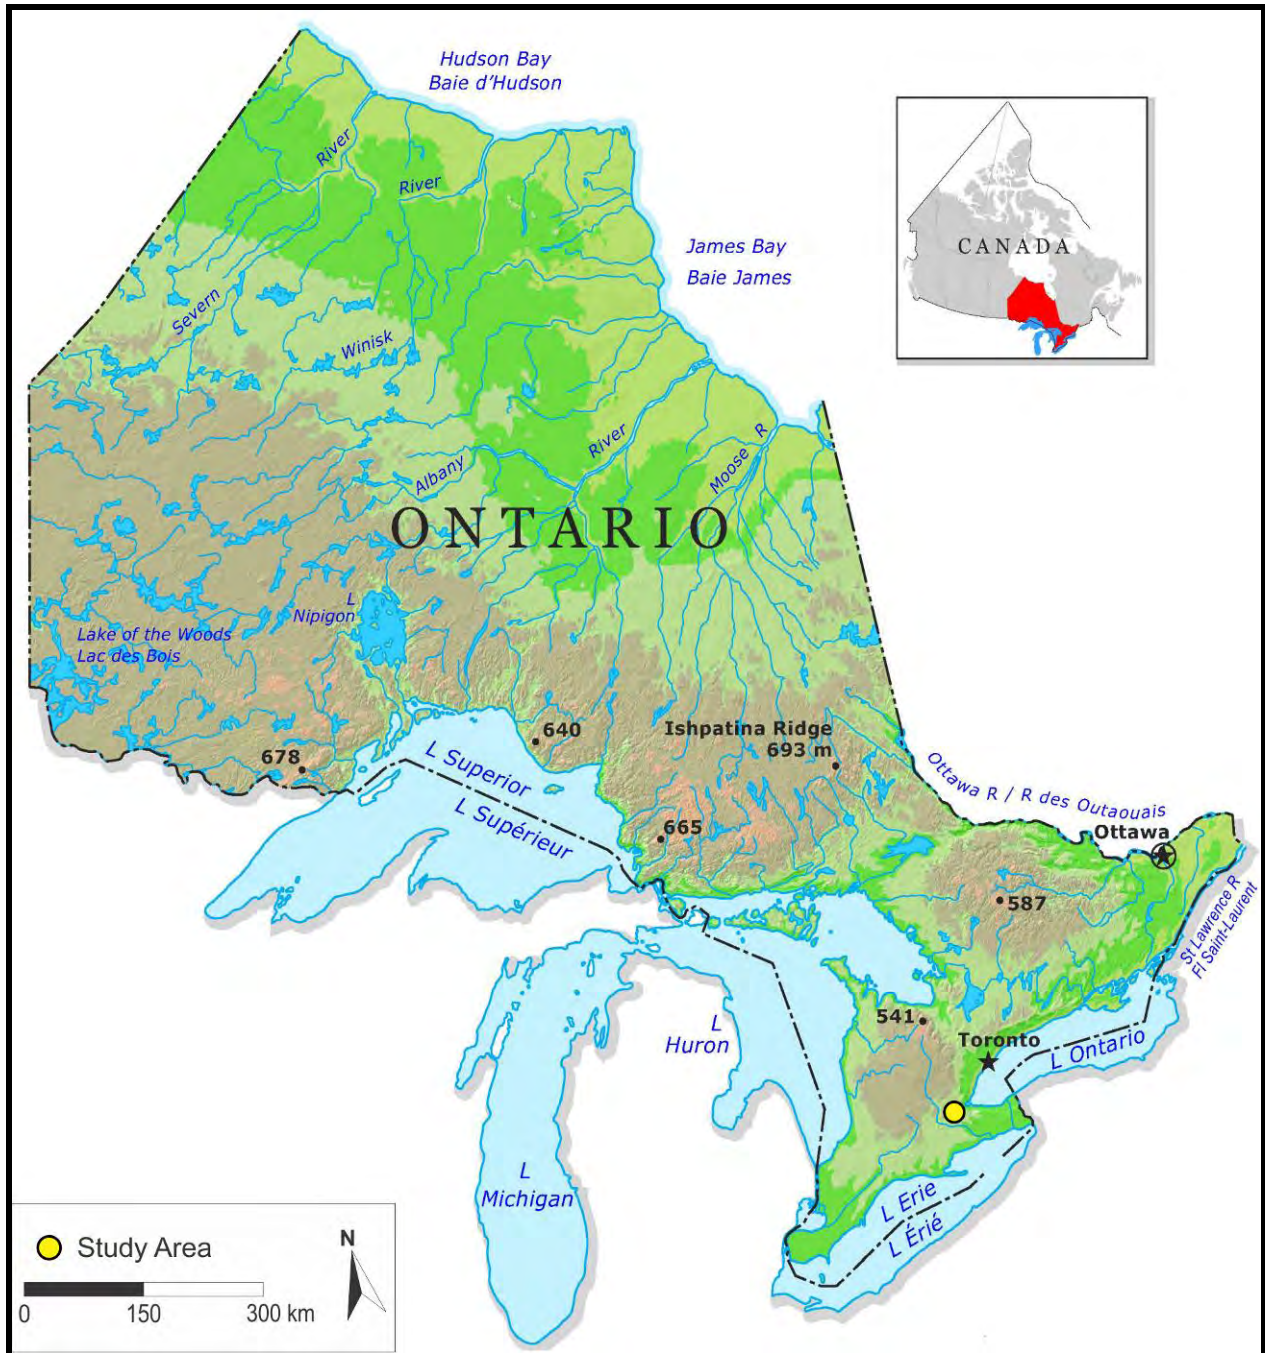
**Map 1: Location of the Study Area in the Province of Ontario (NRC 2002)**

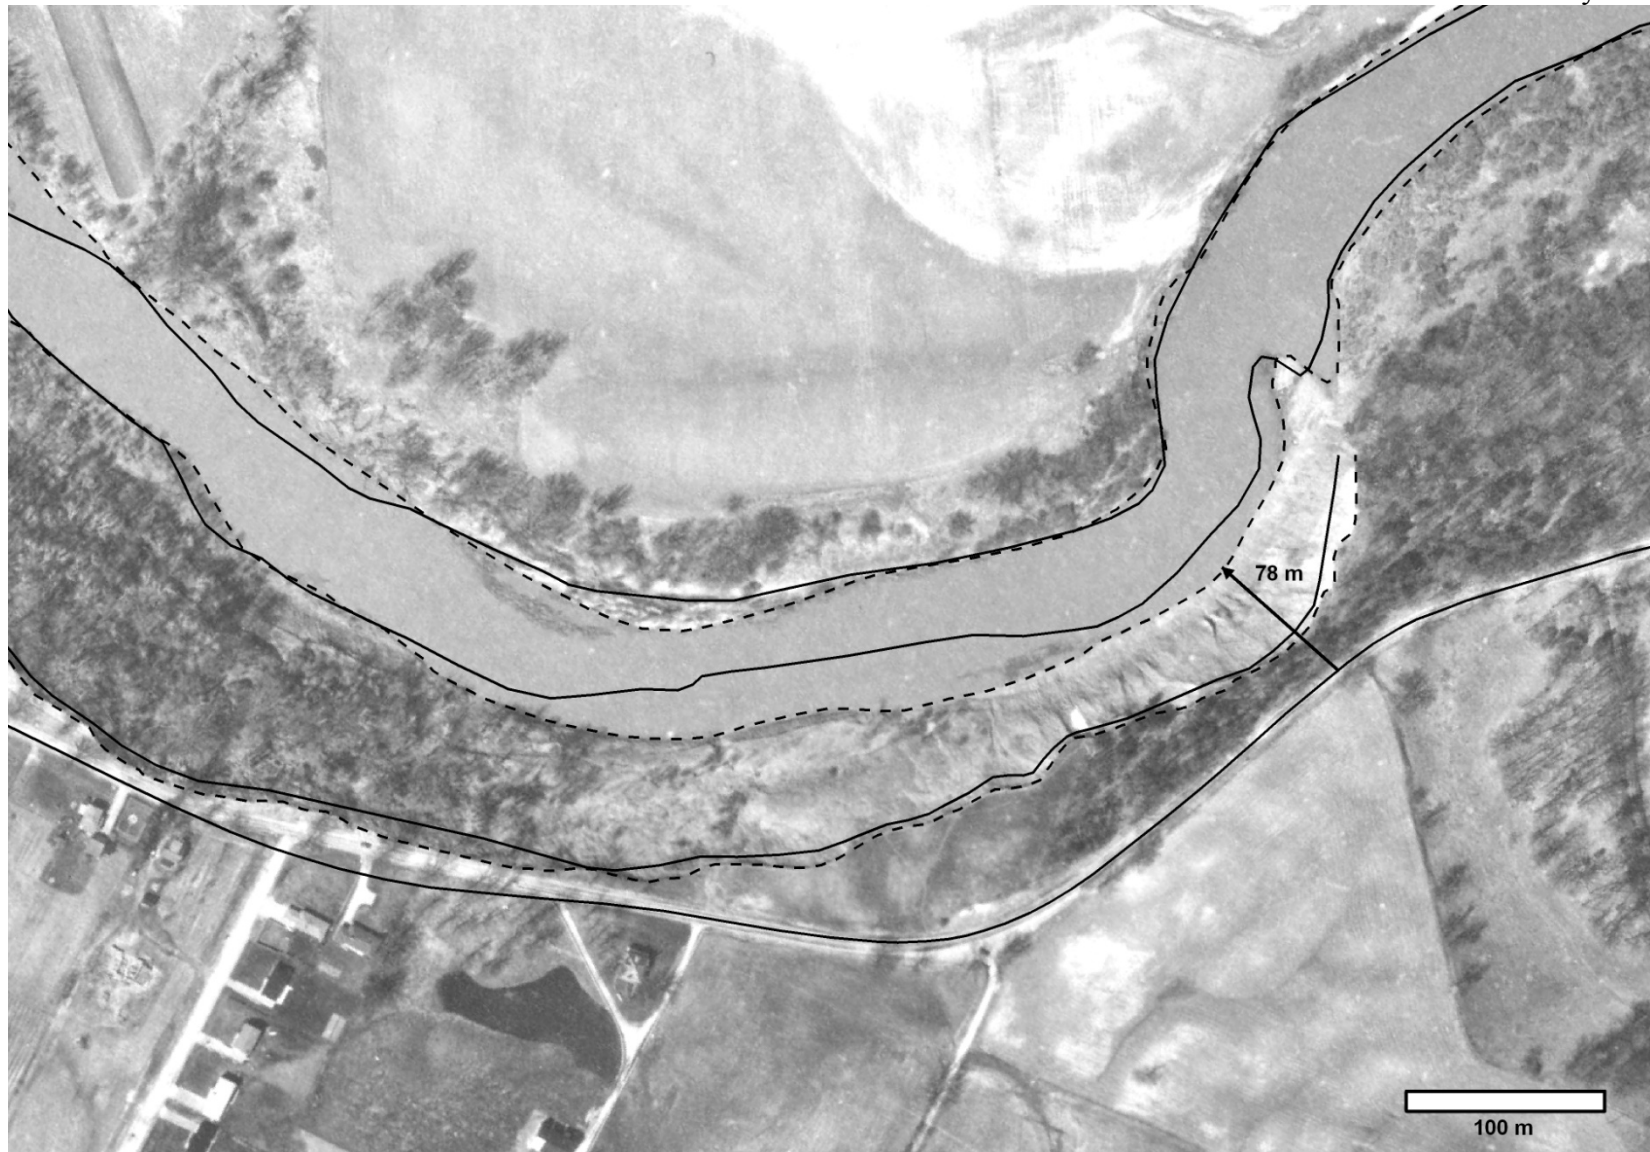
**Figure 4:** Grand River at Tutela 1967 historic imagery. Dashed lines are for water-edge and slope crest in 1967 (Solid lines represent 1945 locations). Arrow indicates representative distance of water-edge from road at cross-section C (**Note:** erosion rates in **Table 1** are calculated based on average erosion over river lengths of 250–550 m). Higher water conditions in 1967 compared to 1945 may overestimate the erosion rate estimate.

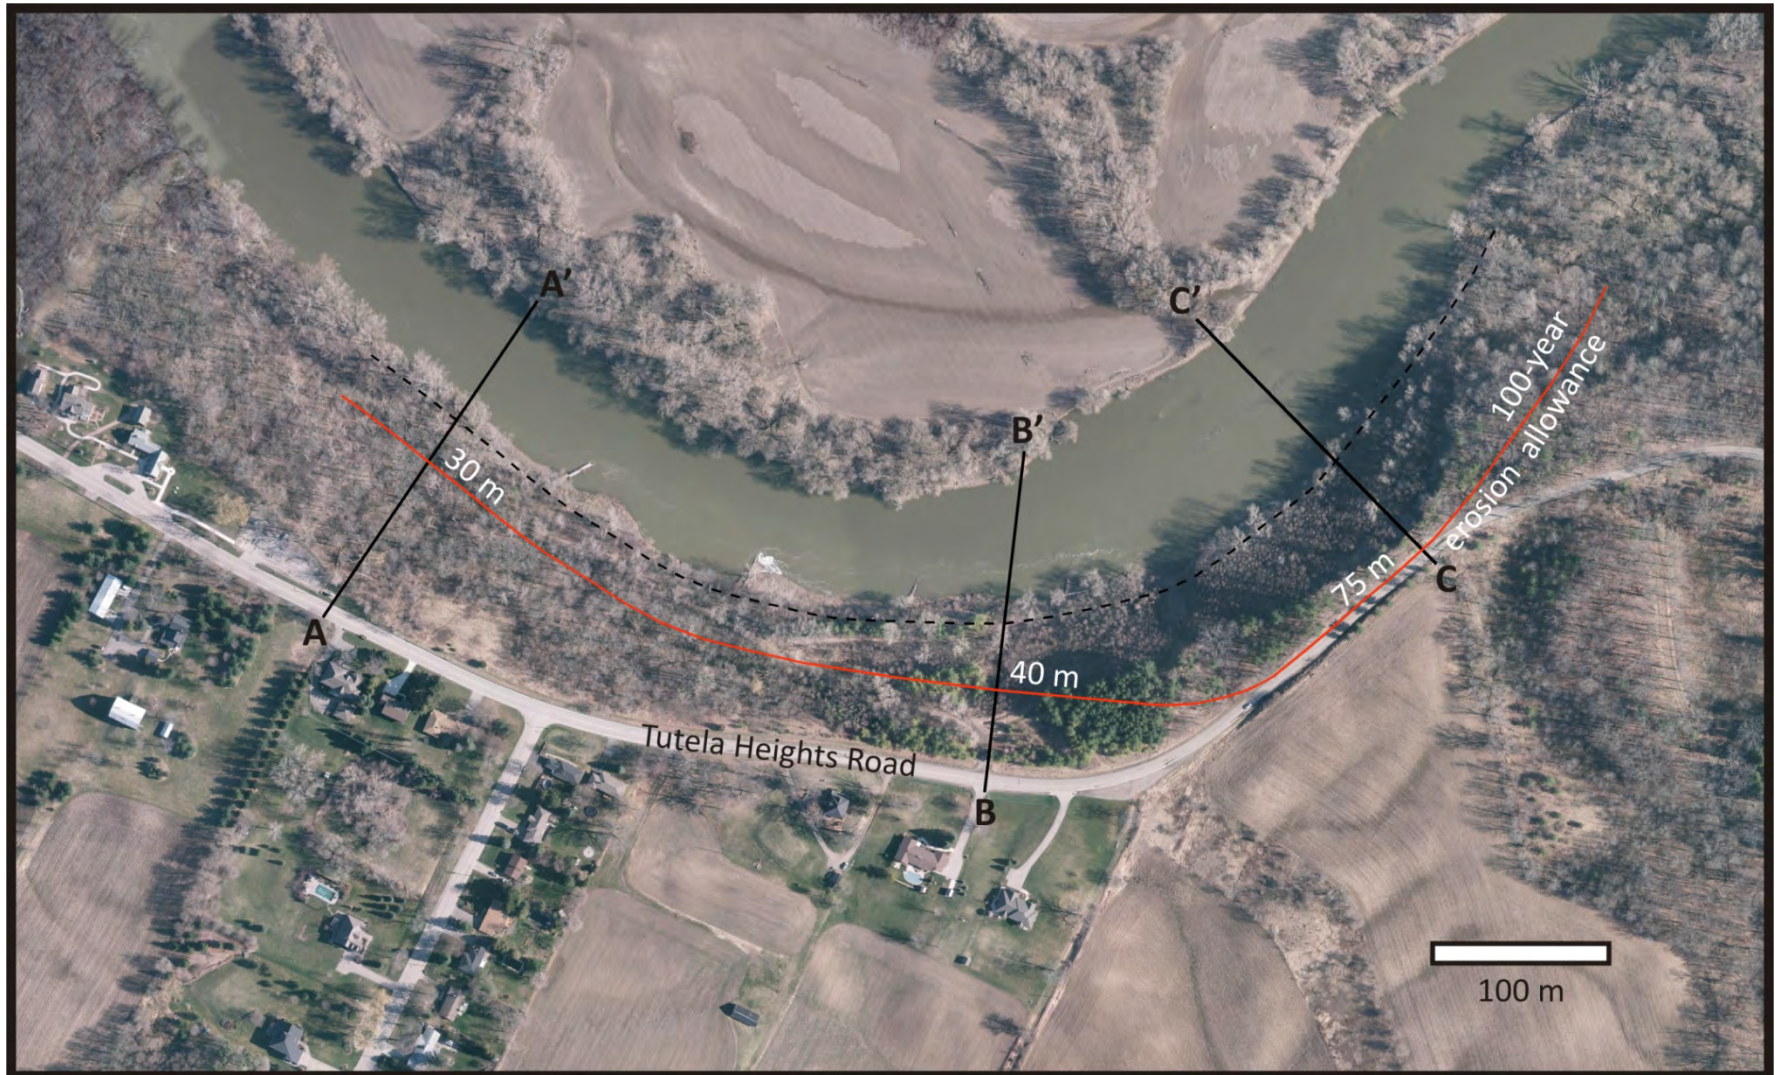
**Figure 8:** Recommended 100-year erosion allowance mapping for Grand River at Tutela Heights Road, including 75 m erosion allowance at cross-section C and 30 m erosion allowance at cross-sections A (with transition offset of 40 m at cross-section B, based on Golder, 1986). Dashed black line represents generalized top of bank for Grand River digitized from 2013 orthophotography.

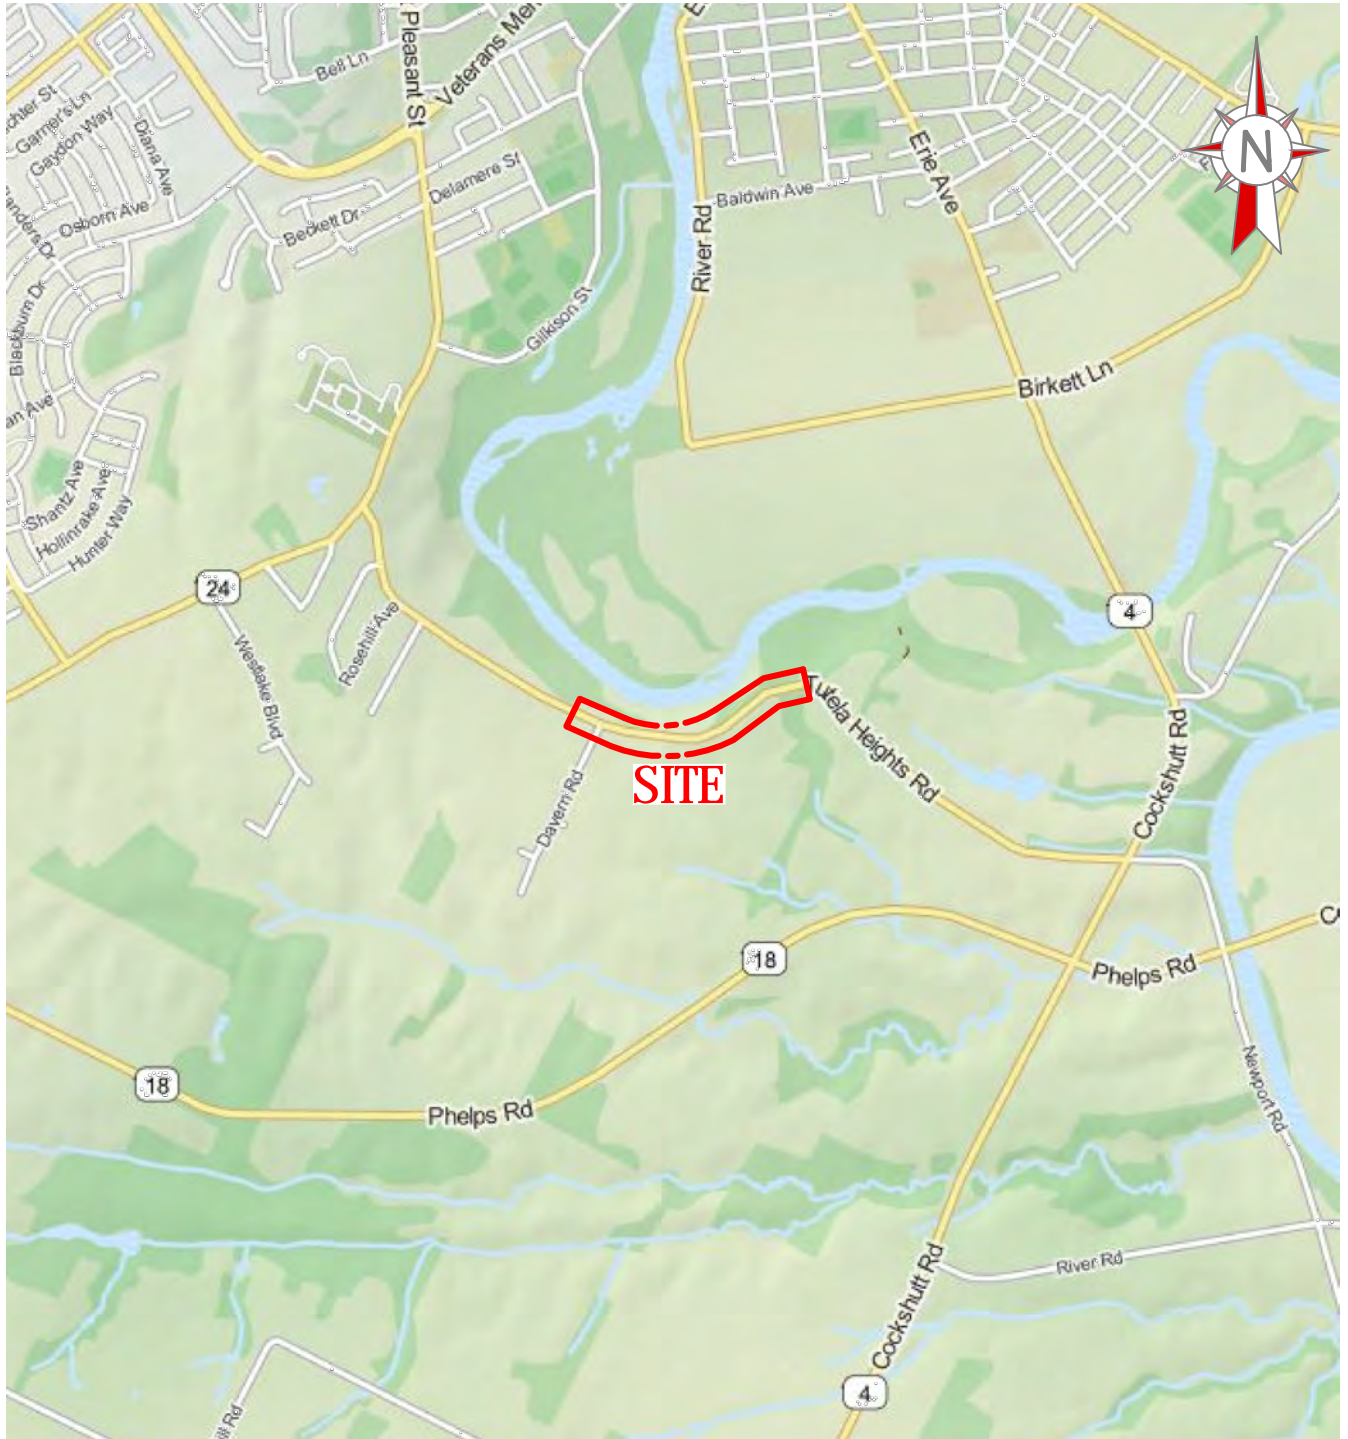
**NOTES :**  
1-REFERENCES : © OpenStreetMap contributors (2015).

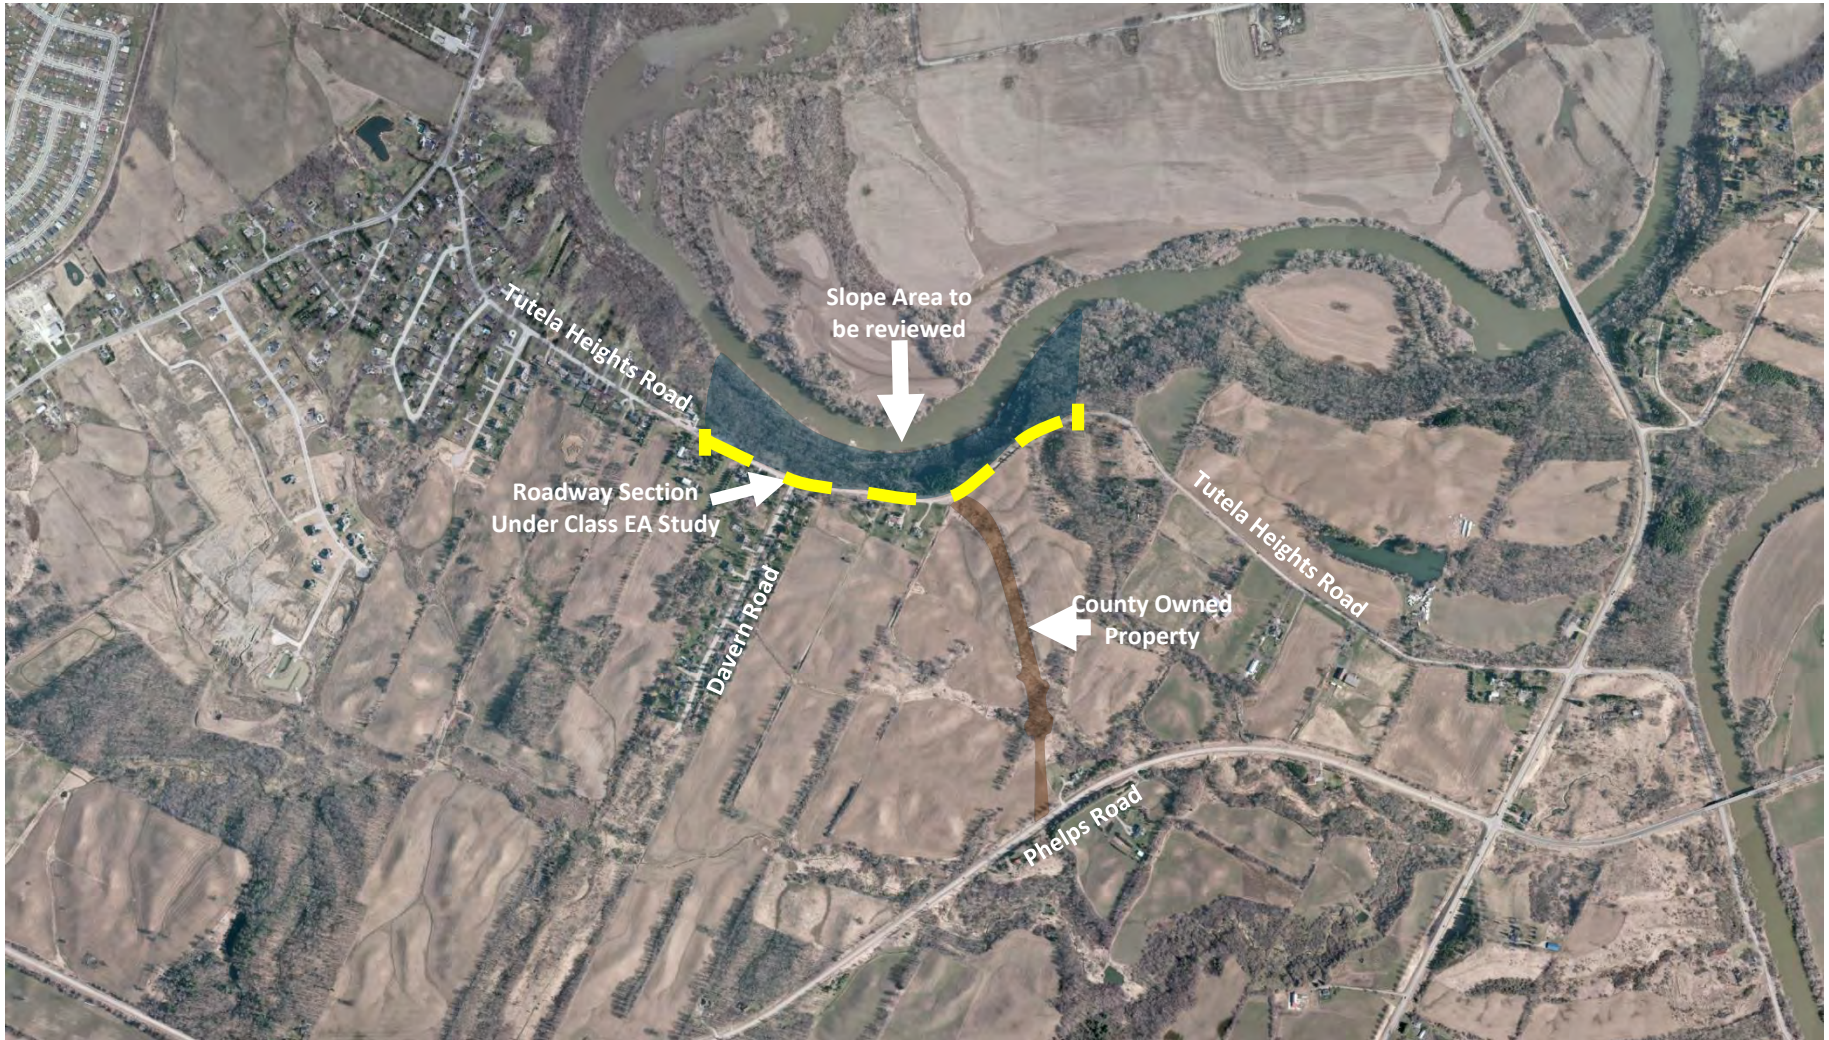
- ❑ The 'Slope Area' north of Tutela Heights Road from the Bell Homestead Property to 1 km east has historically experienced slope failures
- ❑ Slope stabilization measures were undertaken in 1973 by the Grand River Conservation Authority (GRCA)
- ❑ In May 2013 the geotechnical firm LVM undertook inspection and assessment of the 'Slope Area'. As a result of the findings the Grand Valley Trail Association installed additional trail signage and relocated a portion of their trail away from eroded section of the slope.
- ❑ Investigations in 2014 and 2015 have confirmed that sections of the 'Slope Area' continue to be unstable

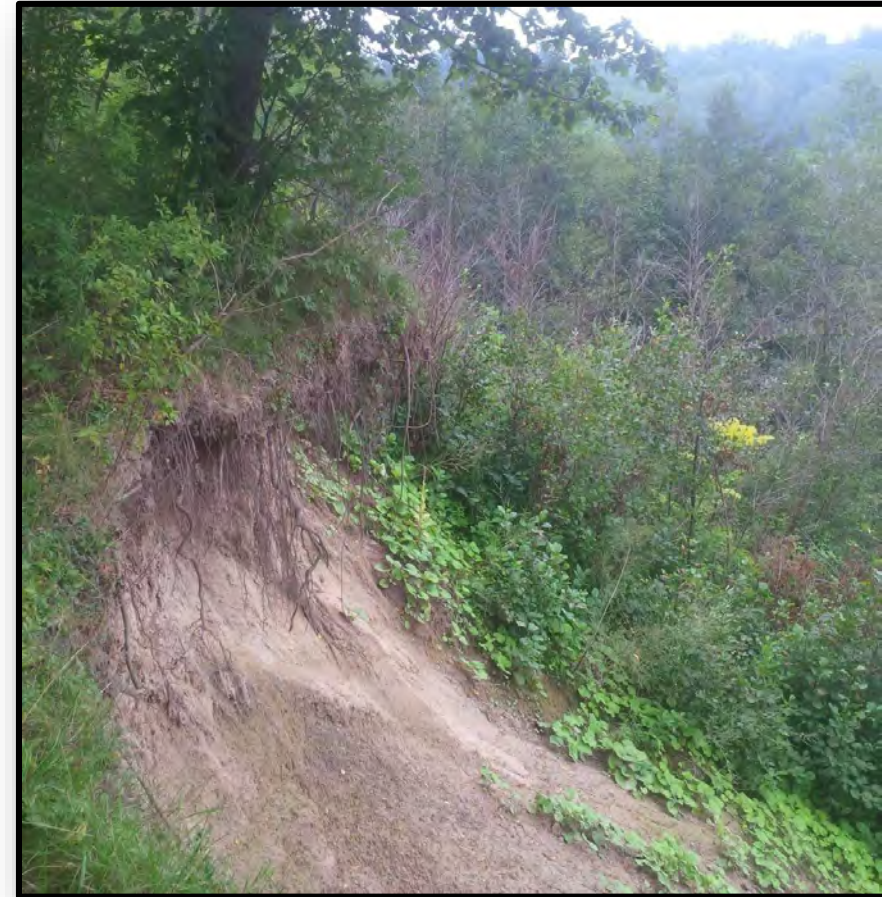
- Formal planning process approved under the **Ontario Environmental Assessment (EA) Act** that must be undertaken in advance of road, water and wastewater construction projects
- Ensures that all **reasonable alternatives** are considered and that a selected alternative would have **minimal impact on the surrounding environment**
- The Municipal Class EA process provides opportunities for public/stakeholder involvement throughout the project
- The Tutela Heights Road Slope Stabilization EA study is being undertaken as a **“Schedule C”** Class EA project

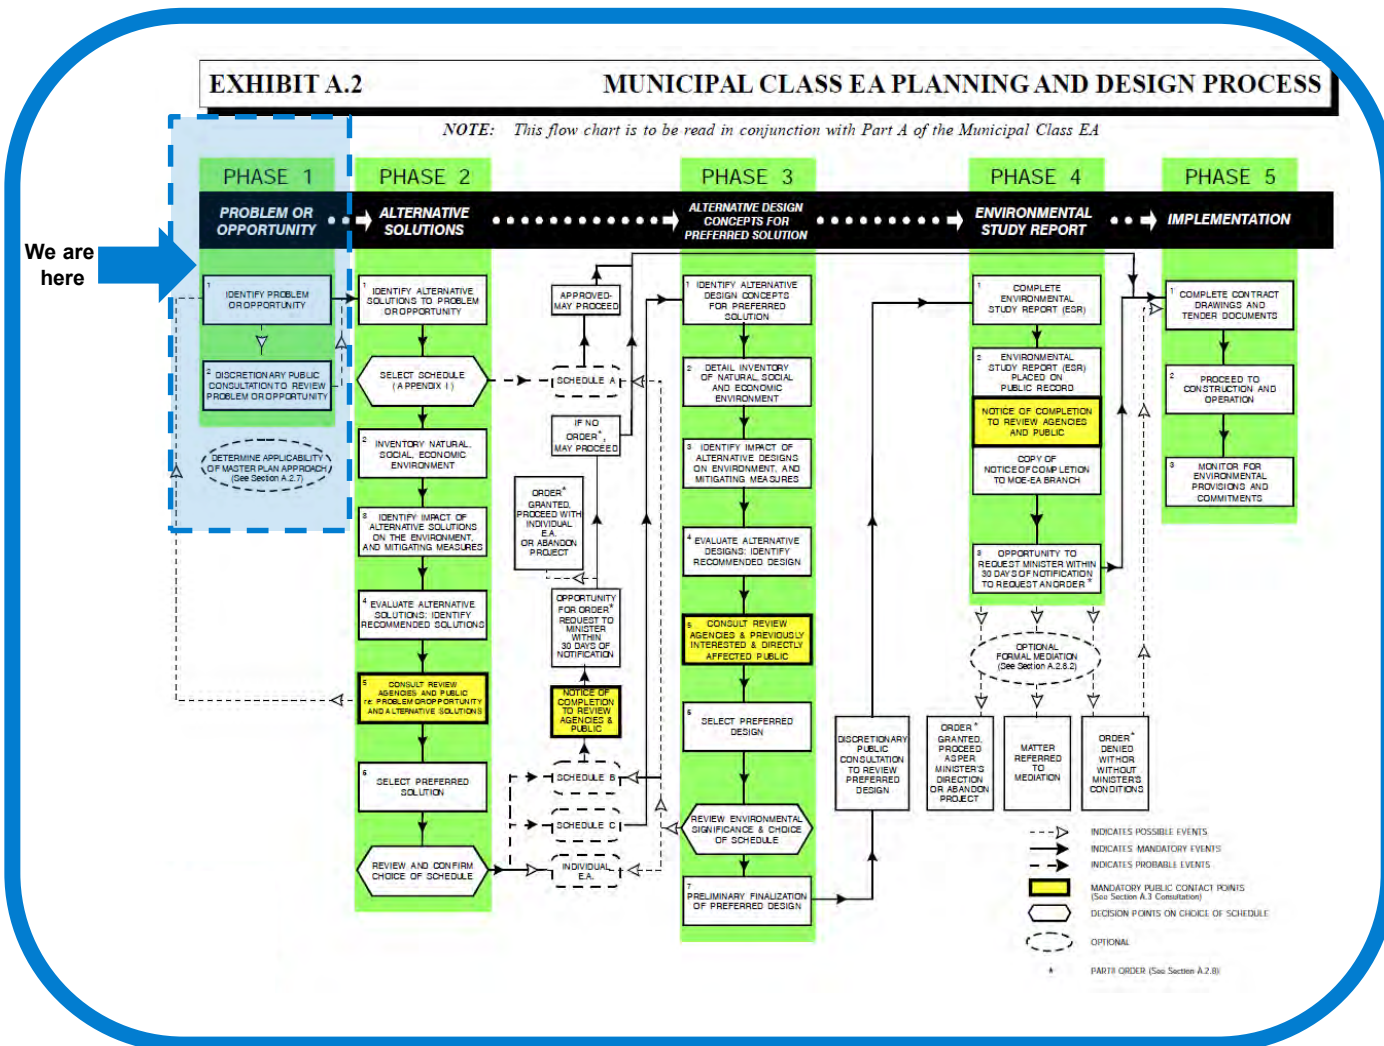
- ❑ The Class EA process for Slope Stabilization involves the determination of the Erosion Hazard Limit (EHL) for the Slope Area
- ❑ Erosion Hazard Limit (EHL) is the limit (setback from the Grand River) within which it would be unsafe to allow development, infrastructure, or site alteration activities
- ❑ EHL is determined using information on the historical erosion rate of the river, an allowance for slope stability, and an allowance for future erosion
- ❑ EHL for the Tutela Heights Road Slope Area will be determined through Geotechnical and Geomorphic Assessments

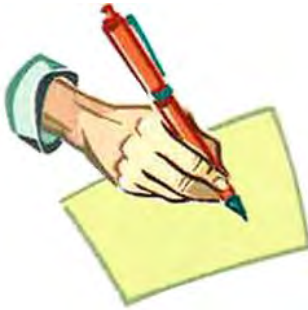
Please complete a Comment Sheet and leave it here today, or return it to Rajan Philips by Friday, October 30, 2015

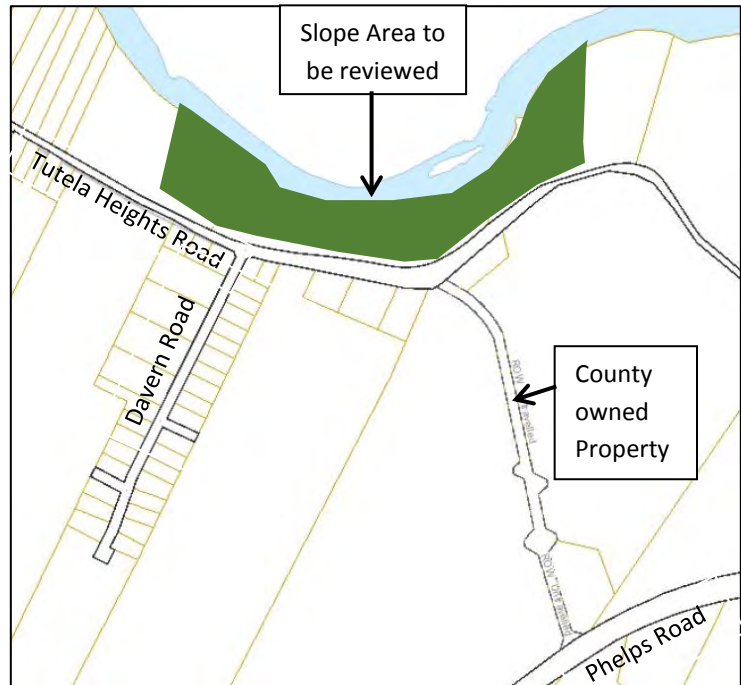
**Public Consultation**

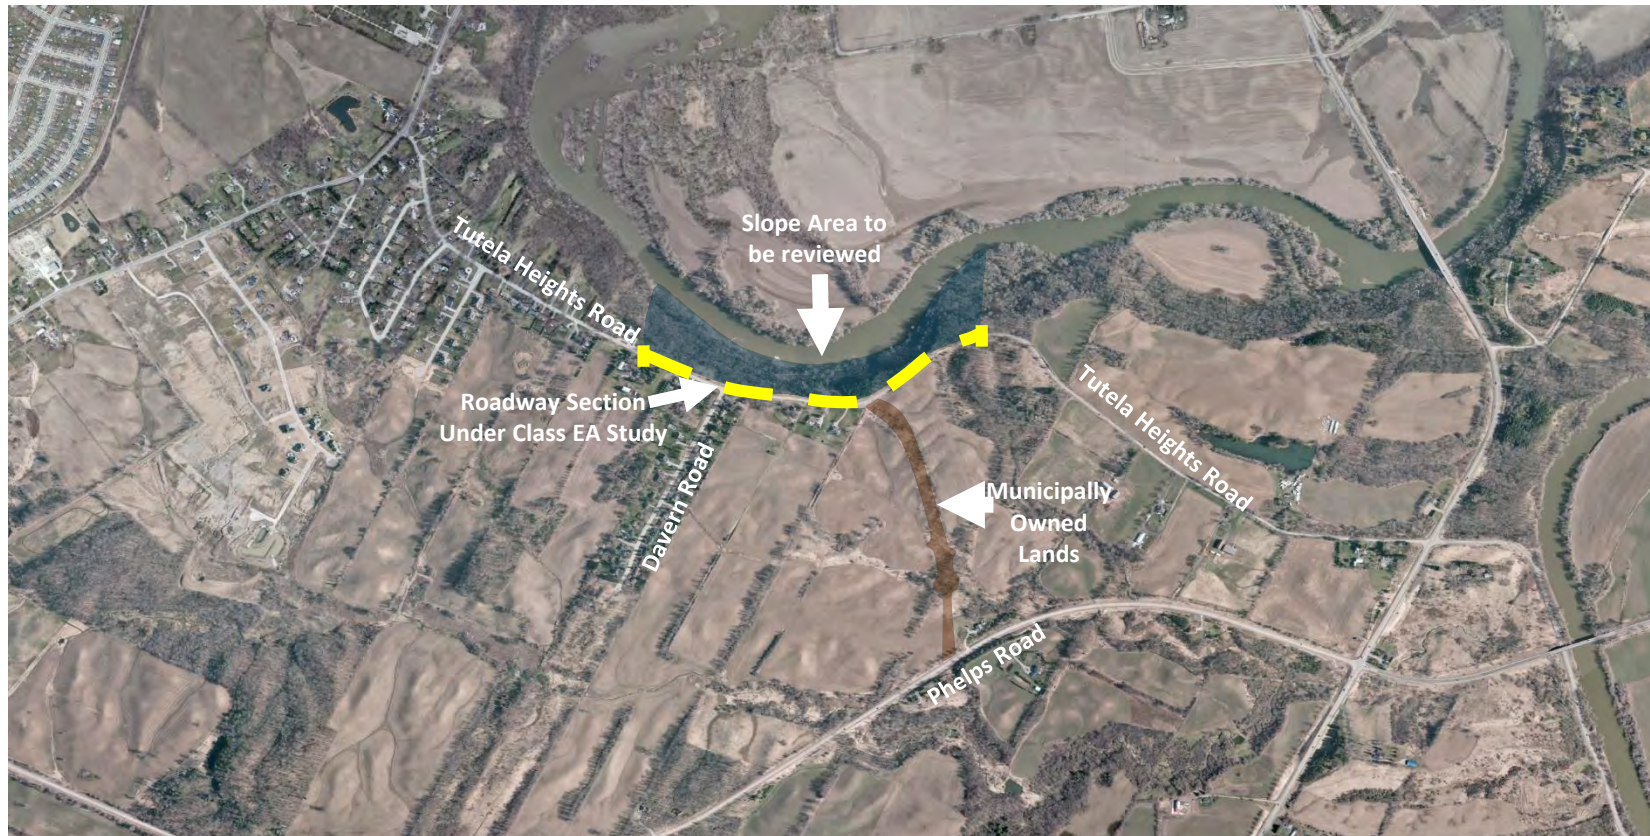
- ❑ The 'Slope Area' north of Tutela Heights Road from the Bell Homestead Property to 1 km east has historically experienced slope failures
- ❑ Slope stabilization measures were undertaken in 1973 by the Grand River Conservation Authority (GRCA)
- ❑ Geotechnical Investigations in 2014 and 2015 have confirmed that sections of the 'Slope Area' continue to be unstable
- ❑ August, 2015: Commencement of Municipal Class EA Study
- ❑ Current Status of Class EA Study:
  - Public Information Centre #1 held on October 14, 2015
  - Assessments of Existing Conditions completed
  - Development and Evaluation of Alternatives
  - Selection of Recommended Alternative
  - Public Information Centre #2
