**PARSONS**

# Project File Report

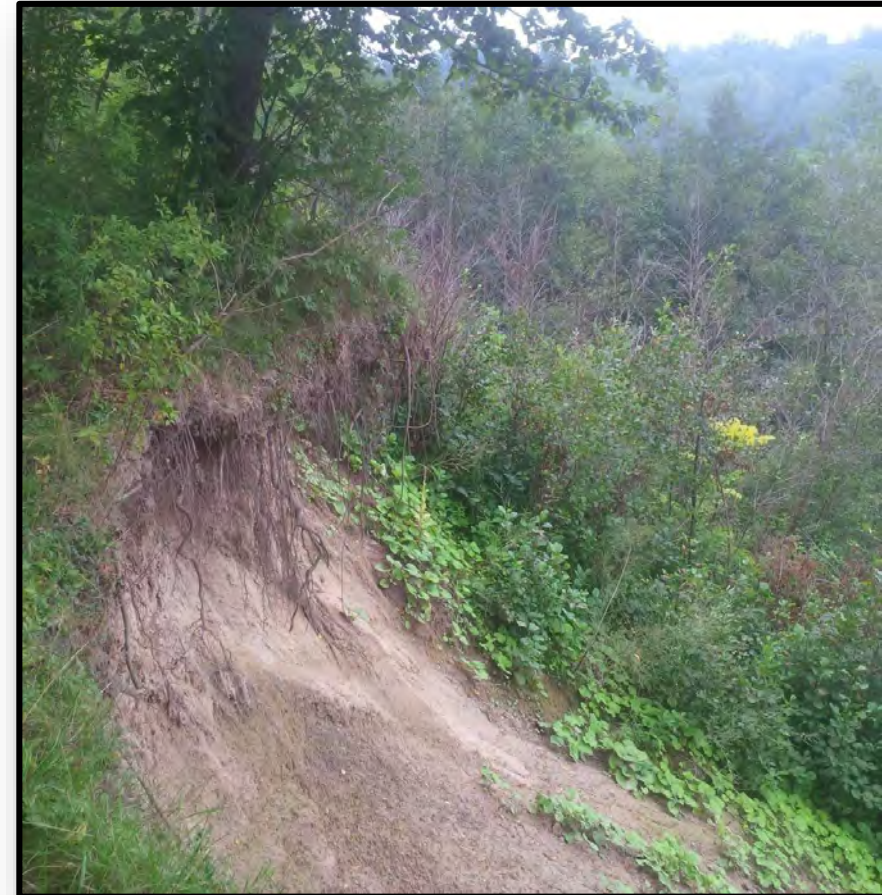
- Formal planning process approved under the **Ontario Environmental Assessment (EA) Act** that must be undertaken in advance of road, water and wastewater construction projects
- Ensures that all **reasonable alternatives** are considered and that a selected alternative would have **minimal impact on the surrounding environment**
- The Municipal Class EA process provides opportunities for public/stakeholder involvement throughout the project
- The Tutela Heights Road Slope Stabilization EA study is being undertaken as a **“Schedule B”** Class EA project

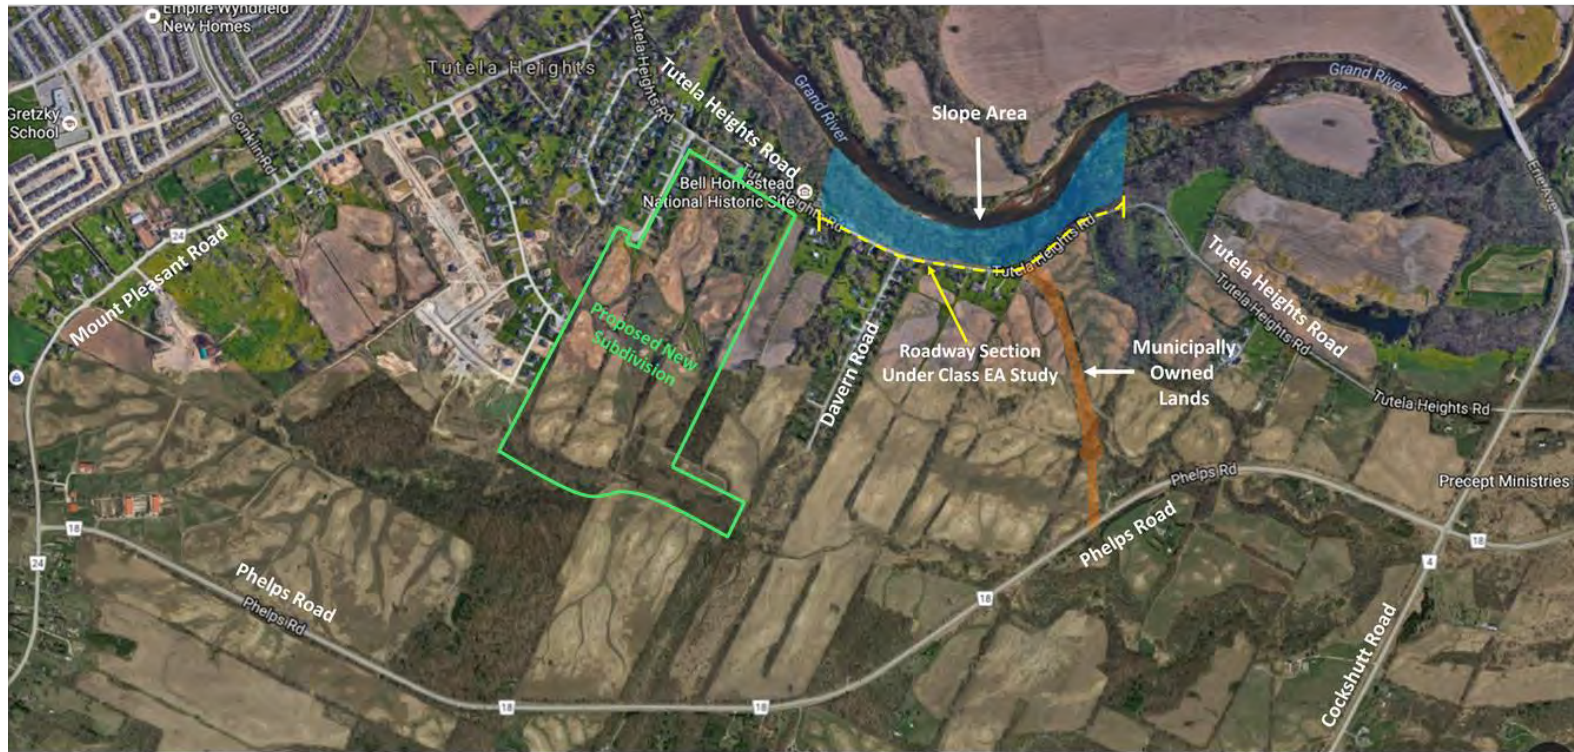
- ❑ Rural Local Road – property access is primary function
- ❑ Connects Mount Pleasant Road and Cockshutt Road – more local traffic than through traffic
- ❑ High level-of-service under current and future (background/development) traffic conditions
- ❑ Existing watermain and limited storm infrastructure

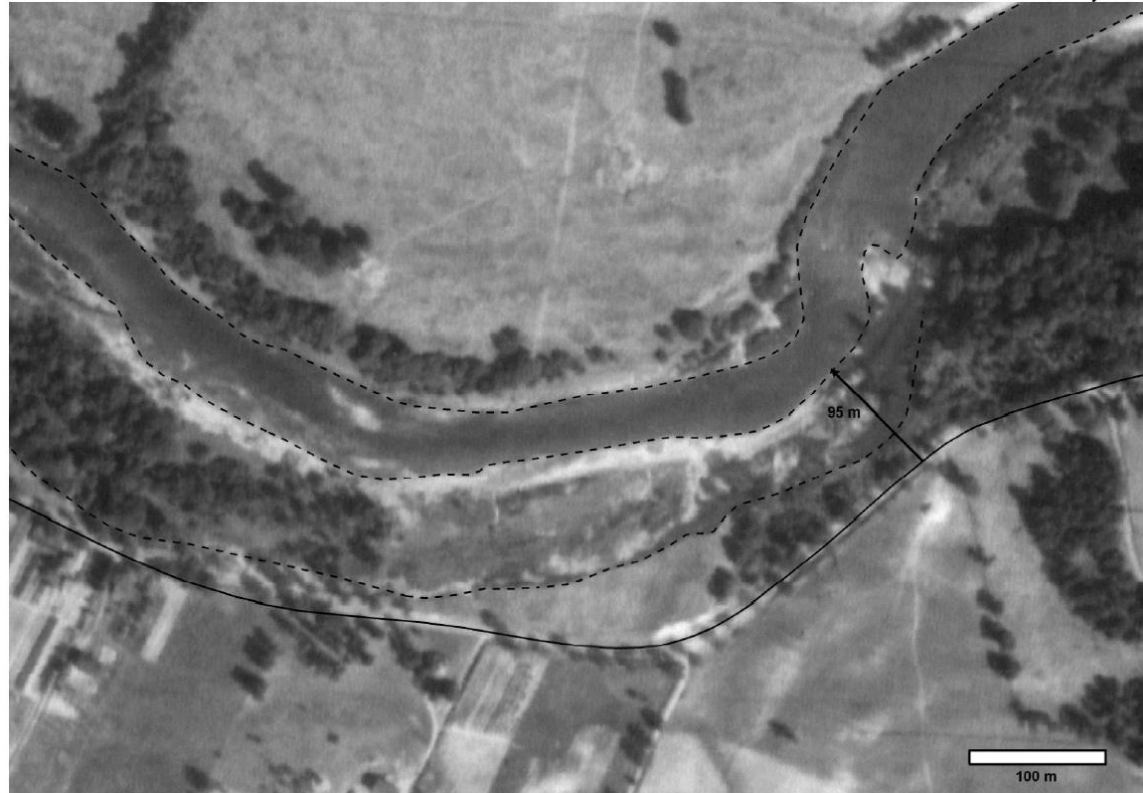
Grand River at Tutela 1945 historic imagery

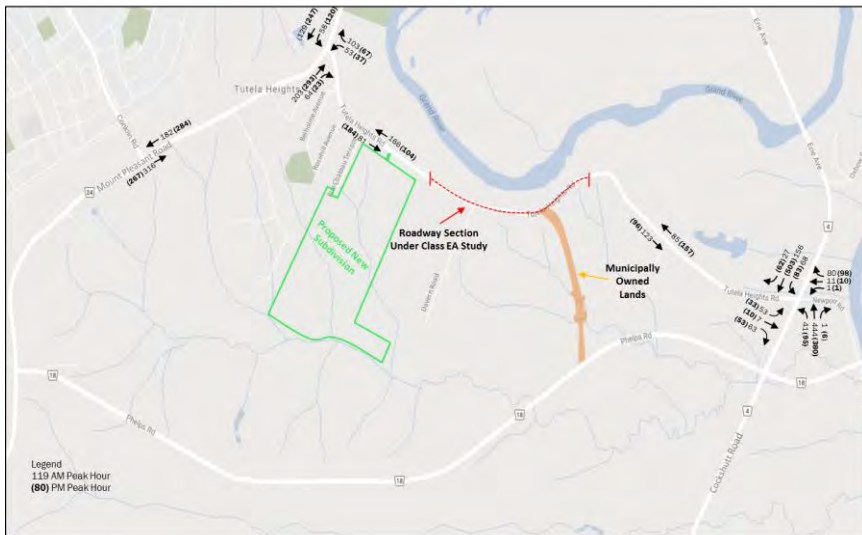
2021 Traffic Volumes  
(including traffic from proposed development)

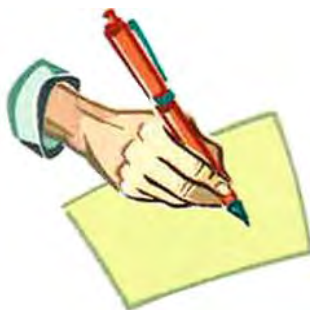
Please complete a Comment Sheet and leave it here today, or return it to Rajan Philips by Friday January 27, 2016
