## Tutela Heights Road Slope Stability Monitoring Program

PROJECT:  
**TUTELA HEIGHTS ROAD SLOPE STABILITY**  
COUNTY OF BRANT

**SITE PLAN**

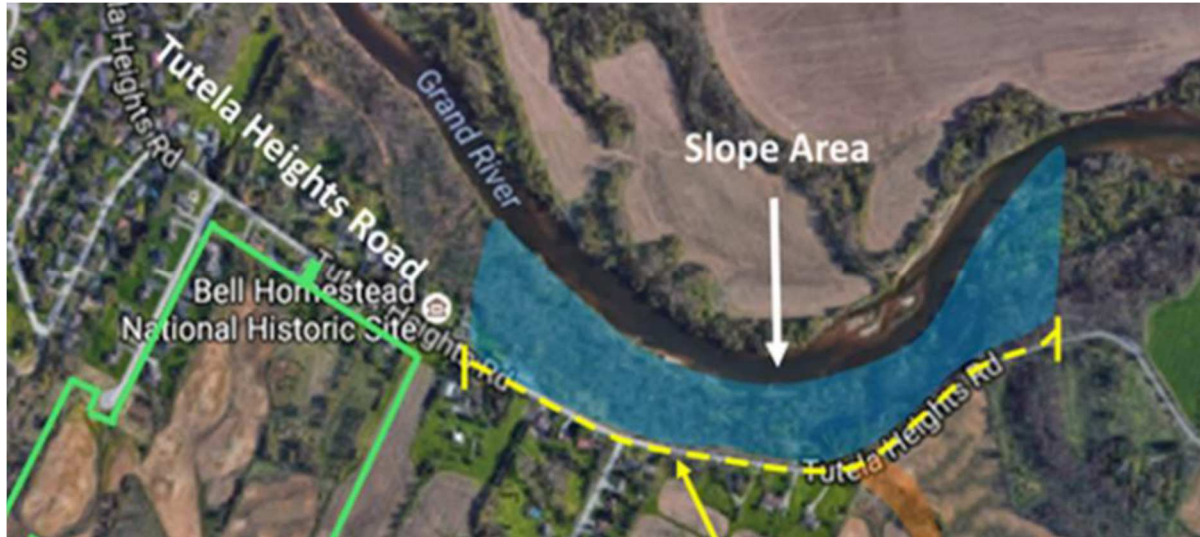
The below program has been developed to monitor the slope along Tutela Heights Road, from the east end of the Bell Homestead property to approximately one kilometre east, as noted as the “Slope Area” below.

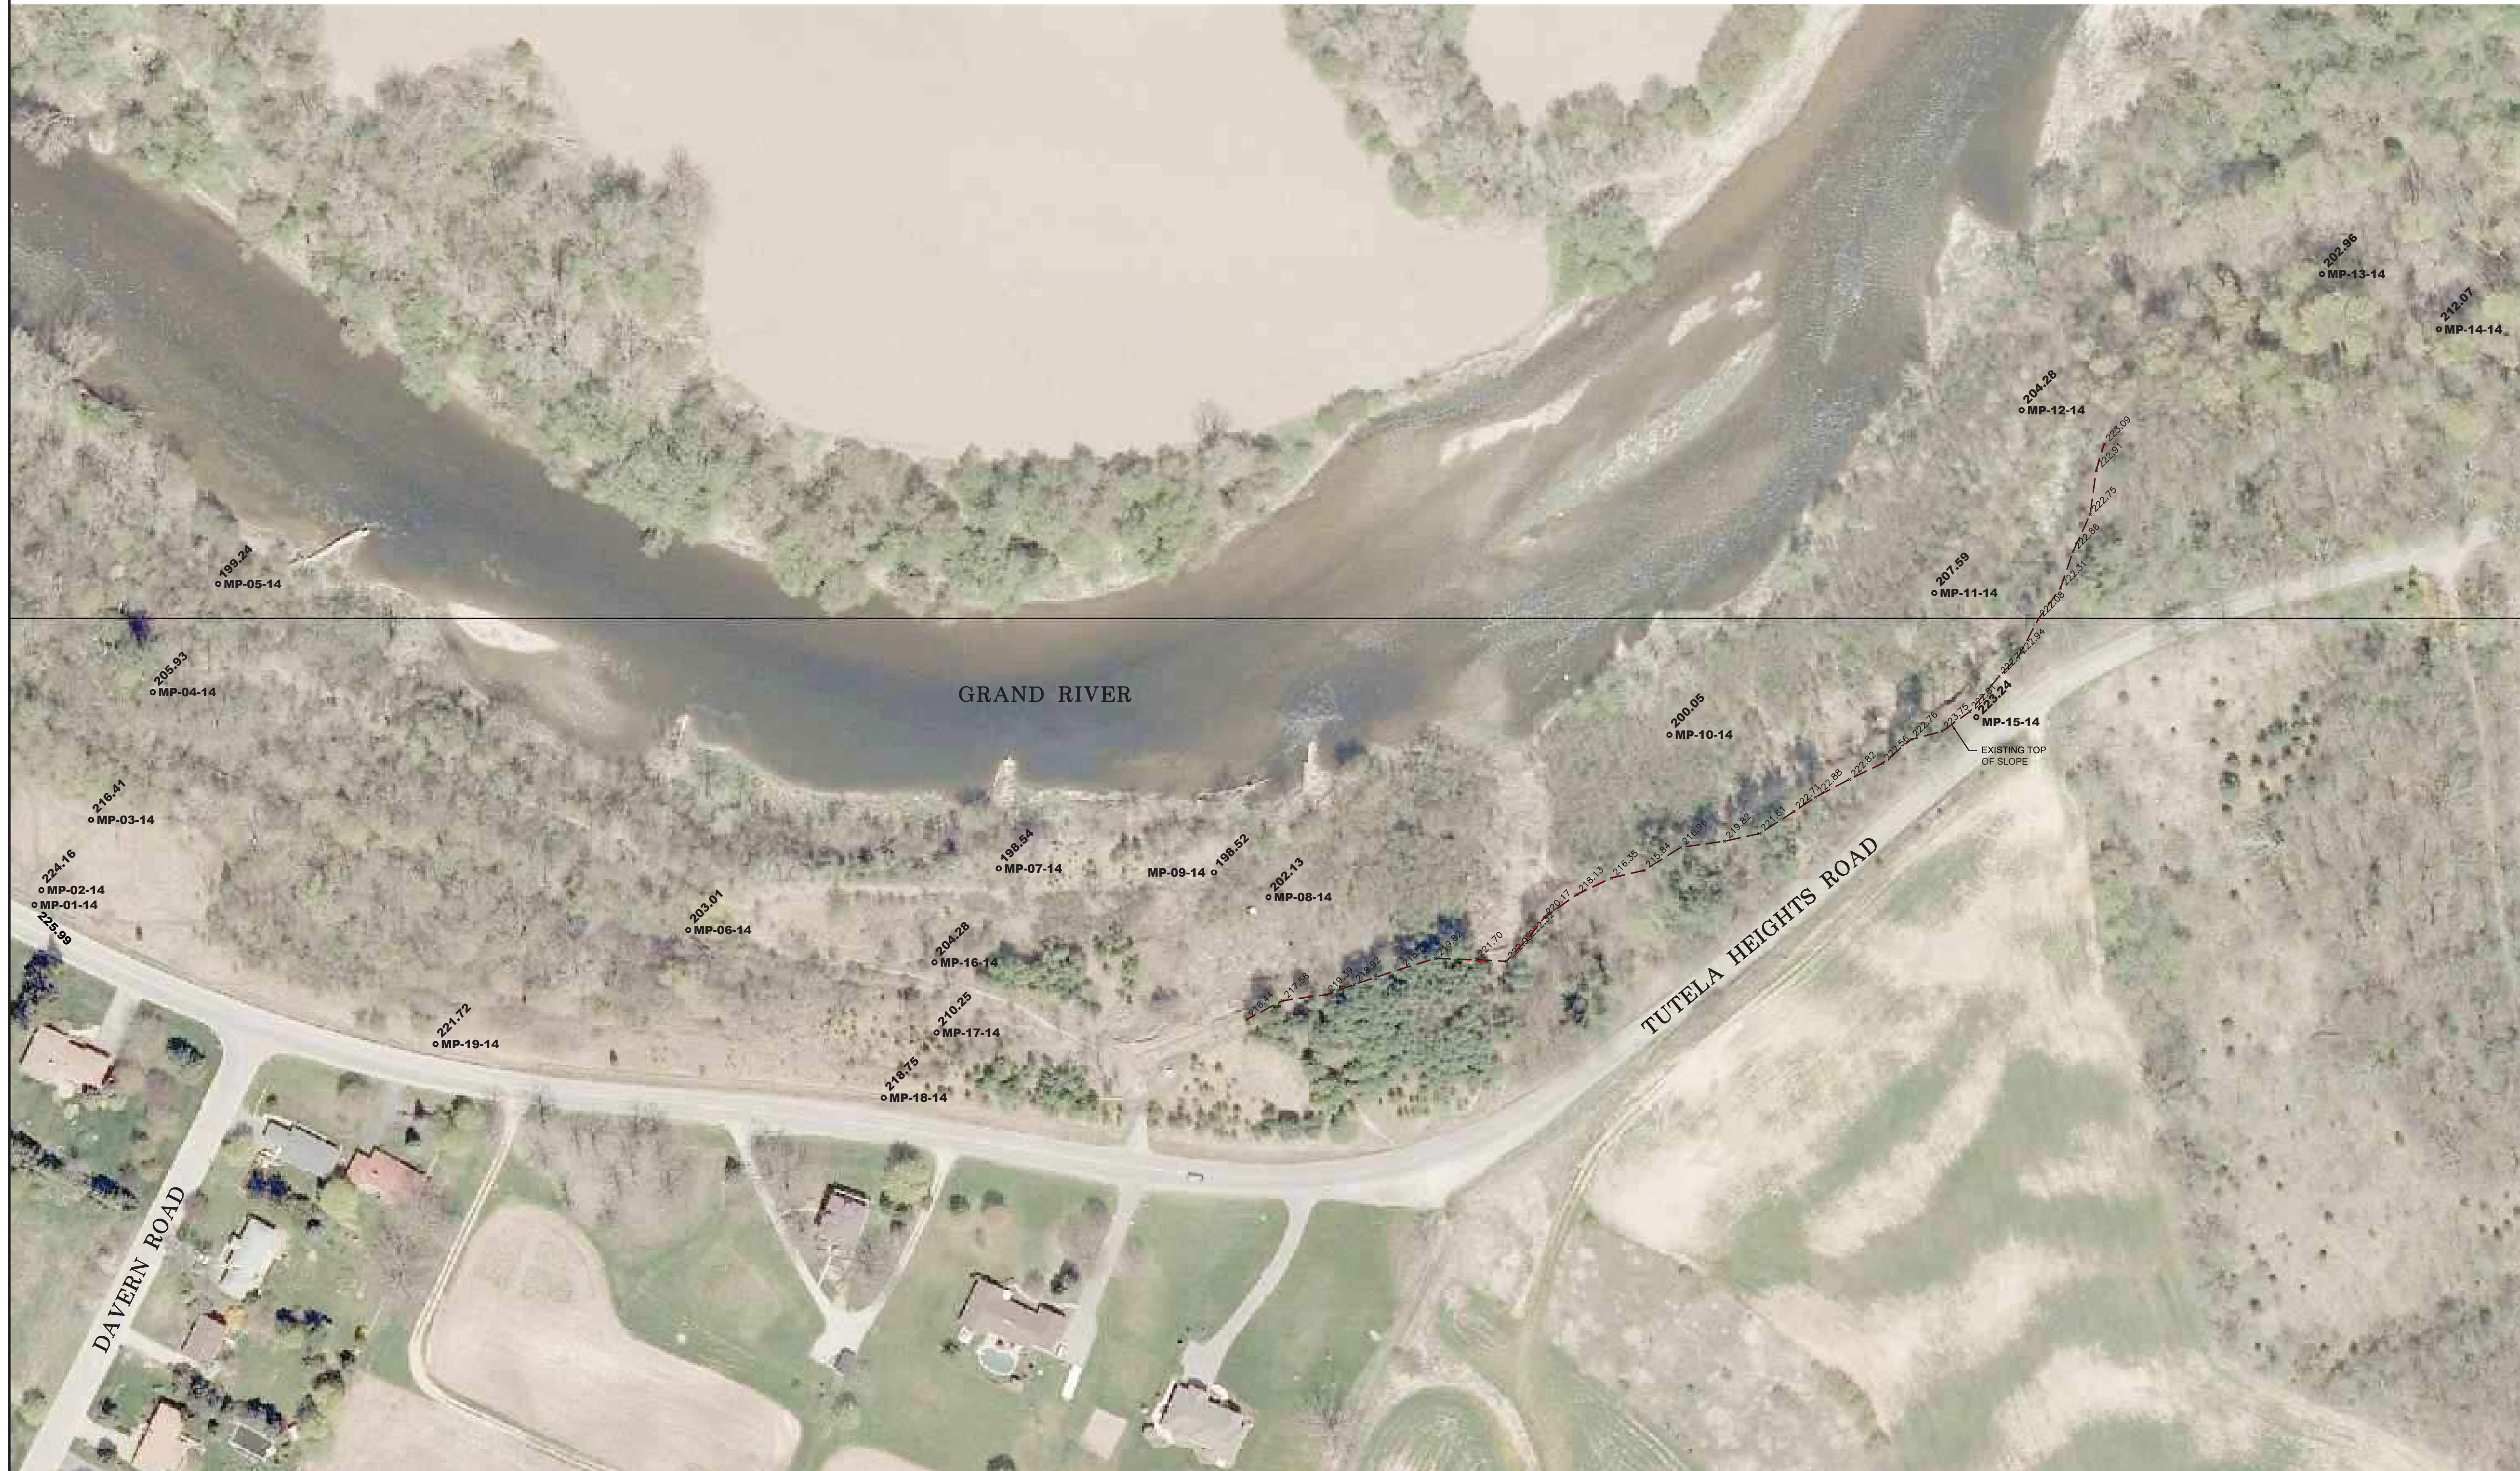
MONITORING POINT - MOVEMENT SUMMARY (PLANTED BARS)																																																									
	MP-01-14			MP-02-14			MP-03-14			MP-04-14			MP-05-14			MP-06-14			MP-07-14			MP-08-14			MP-09-14			MP-10-14			MP-11-14			MP-12-14			MP-13-14			MP-14-14			MP-15-14			MP-16-14			MP-17-14			MP-18-14			MP-19-14		
	ELEV.	HORZ. CHANGE	N.S.E.W. CHANGE	ELEV.	HORZ. CHANGE	N.S.E.W. CHANGE	ELEV.	HORZ. CHANGE	N.S.E.W. CHANGE	ELEV.	HORZ. CHANGE	N.S.E.W. CHANGE	ELEV.	HORZ. CHANGE	N.S.E.W. CHANGE	ELEV.	HORZ. CHANGE	N.S.E.W. CHANGE	ELEV.	HORZ. CHANGE	N.S.E.W. CHANGE	ELEV.	HORZ. CHANGE	N.S.E.W. CHANGE	ELEV.	HORZ. CHANGE	N.S.E.W. CHANGE	ELEV.	HORZ. CHANGE	N.S.E.W. CHANGE	ELEV.	HORZ. CHANGE	N.S.E.W. CHANGE	ELEV.	HORZ. CHANGE	N.S.E.W. CHANGE	ELEV.	HORZ. CHANGE	N.S.E.W. CHANGE	ELEV.	HORZ. CHANGE	N.S.E.W. CHANGE	ELEV.	HORZ. CHANGE	N.S.E.W. CHANGE												
JAN. 13/2015	225.99	---	---	224.16	---	---	216.41	---	---	205.93	---	---	199.24	---	---	203.01	---	---	198.54	---	---	202.13	---	---	198.52	---	---	200.05	---	---	207.59	---	---	204.28	---	---	202.96	---	---	212.07	---	---	223.24	---	---	204.28	---	---	210.25	---	---	218.75	---	---	221.72	---	---

APR. 24/2015	225.99	0.02m		224.17	0.02m		216.39	0.02m		205.95	0.02m		199.16	0.01m		203.00	0.05m		198.54	0.04m		202.11	0.04m		198.52	0.03m		200.08	0.02m		207.60	0.01m		204.22	0.04m		202.98	0.01m		212.07	0.05m		223.24	0.04m		204.27	0.02m		210.25	0.01m		218.73	0.03m		221.71	0.04m	
NOV. 5/2015	225.99	0.02m		224.15	0.02m		216.43	0.03m		205.91	0.05m		199.23	0.02m		203.00	0.02m		198.55	0.02m		202.10	0.02m		198.50	0.00m		200.01	0.04m		207.60	0.04m		204.27	0.02m		202.96	0.01m		212.04	0.05m		223.21	0.01m		204.28	0.01m		210.26	0.01m		218.74	0.02m		221.71	0.01m	
MAY 8/2018 (DISTURBED)	225.95	0.16m		224.13	0.04m		216.37	0.03m		205.88	0.05m		199.16	0.05m		202.94	0.02m		198.52	0.07m		202.06	0.31m		198.48	0.05m		200.00	0.04m		207.57	0.21m		204.27	0.02m		202.95	0.06m		212.03	0.27m		223.16	0.04m		204.21	0.05m		210.24	0.03m		218.73	0.03m		221.69	0.03m	
DEC. 11/2018	225.94	0.14m	S 0.12m W 0.07m	224.12	0.03m	N 0.03m E 0.02m	216.87	0.04m	N 0.04m E 0.01m	205.85	0.04m	N 0.04m E 0.02m	199.15	0.07m	N 0.07m E 0.02m	202.96	0.05m	N 0.05m E 0.02m	198.50	0.07m	N 0.07m W 0.01m	202.09	0.37m	N 0.35m E 0.11m	198.46	0.04m	N 0.04m E 0.02m	200.03	0.03m	N 0.03m W 0.01m	207.53	0.23m	N 0.15m W 0.18m	204.21	0.04m	N 0.04m W 0.01m	202.99	0.05m	N 0.05m E 0.00m	212.02	0.27m	N 0.27m E 0.01m	223.22	0.01m	S 0.01m E 0.01m	204.21	0.04m	N 0.03m E 0.02m	210.24	0.03m	S 0.01m E 0.03m	218.72	0.02m	N 0.02m E 0.01m	221.70	0.02m	N 0.01m E 0.02m

1. MONITORING POINTS IN THIS CHART PLANTED ON JAN. 13/2015.  
2. DISTANCE CHANGE IS FROM THE JAN. 13/2015 LOCATIONS.  
3. NORTH/SOUTH/EAST/WEST (N.S.E.W.) CHANGE IS FROM THE JAN. 13/2015 LOCATIONS.

- ALL ELEVATIONS & DISTANCES SHOWN ARE METRIC.
- MONITORING POINTS PLANTED ON JAN. 13/2015.
- HORIZONTAL MEASUREMENTS ACCURATE TO ±0.02m
